Coated and Uncoated MM137 Braze Alloy Mixture Stress Rupture Chart;  
Base Metal Alloy; CMSX-3; Braze Joints with 0.040" and 0.005" Gaps

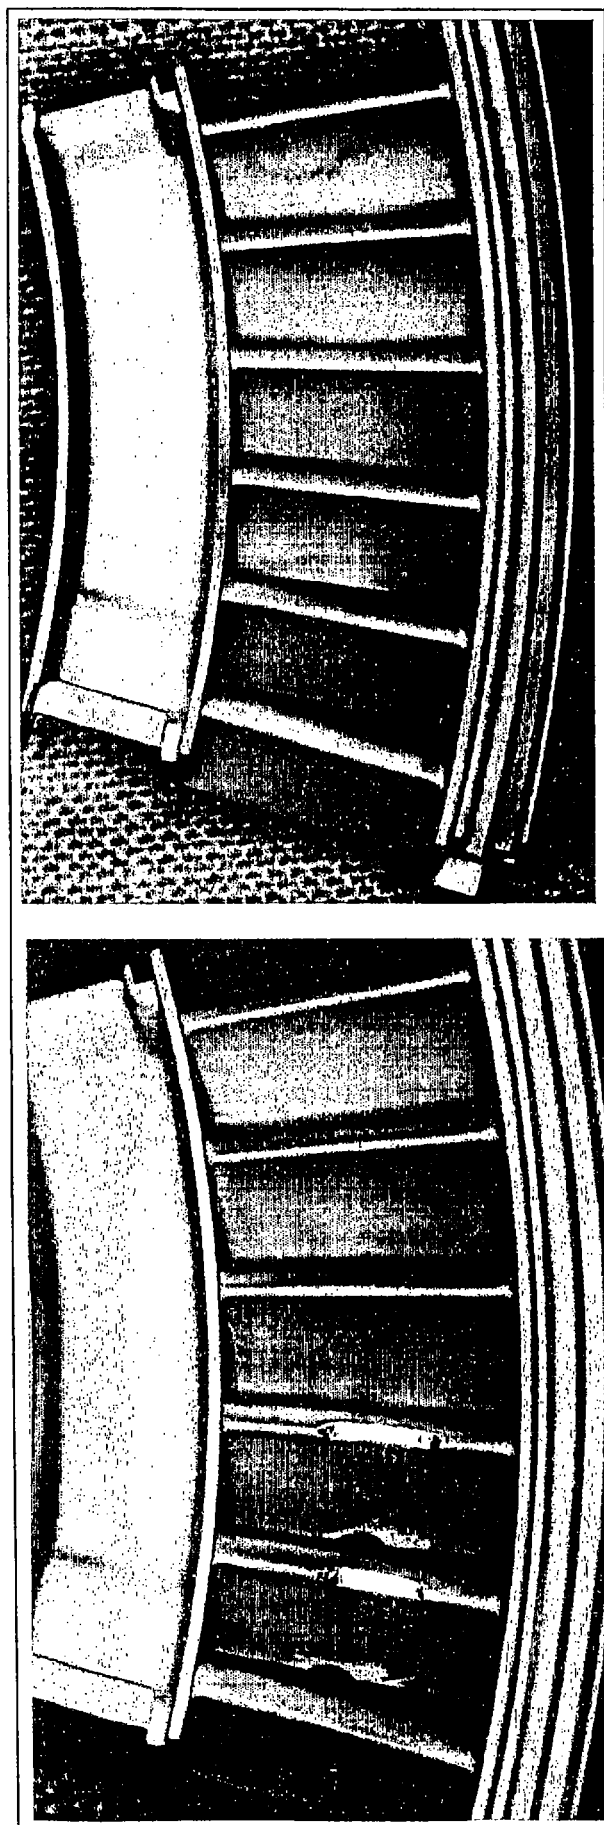
**Fig. 5a**

Leading edge sides of vane segment prior to and after braze repair.

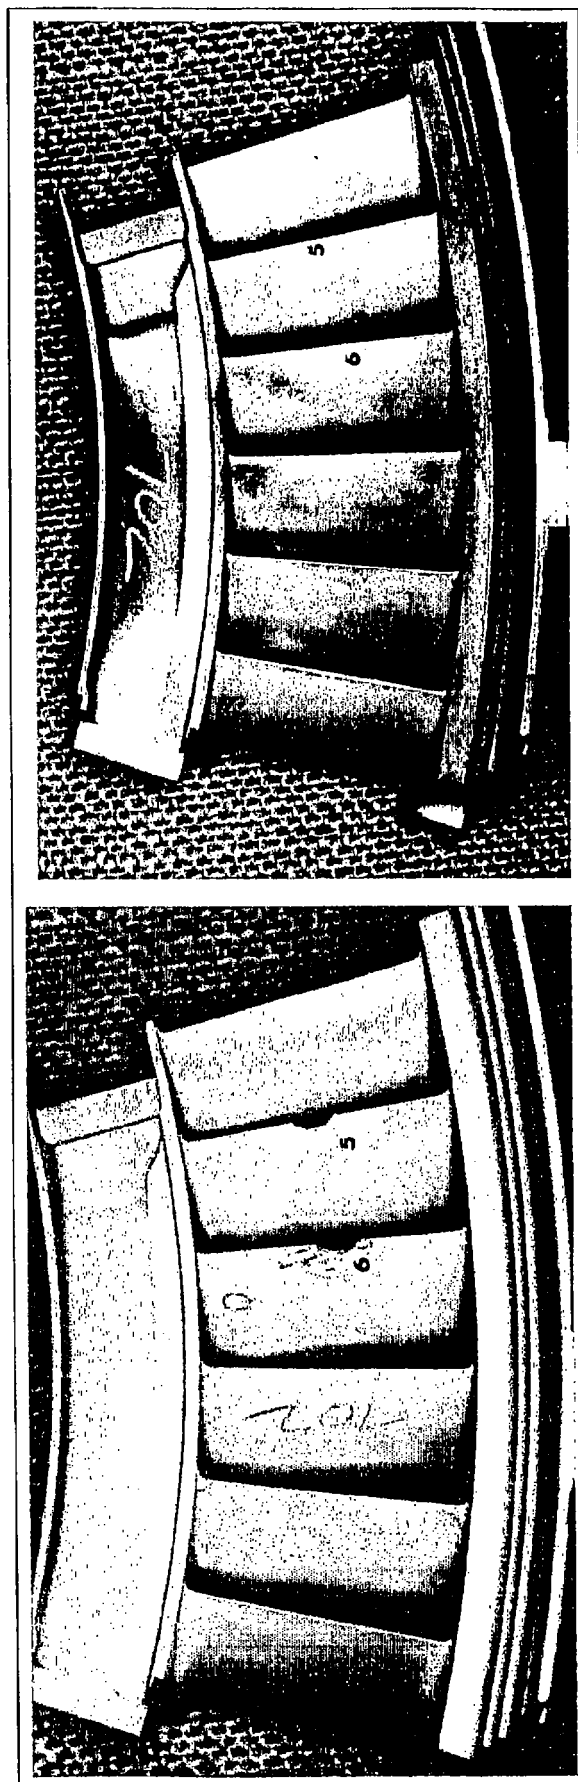
**Fig. 5b**

Trailing edge sides of vane segment prior to and after braze repair.
