### Cross-Section Structure

## Sampled Locations

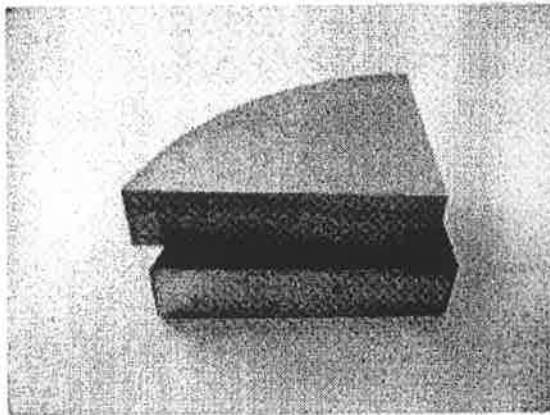
[Fig. 3]

Peeling occurred during the processing.  
→ It is because these are not bonded or the bond strength is weak.

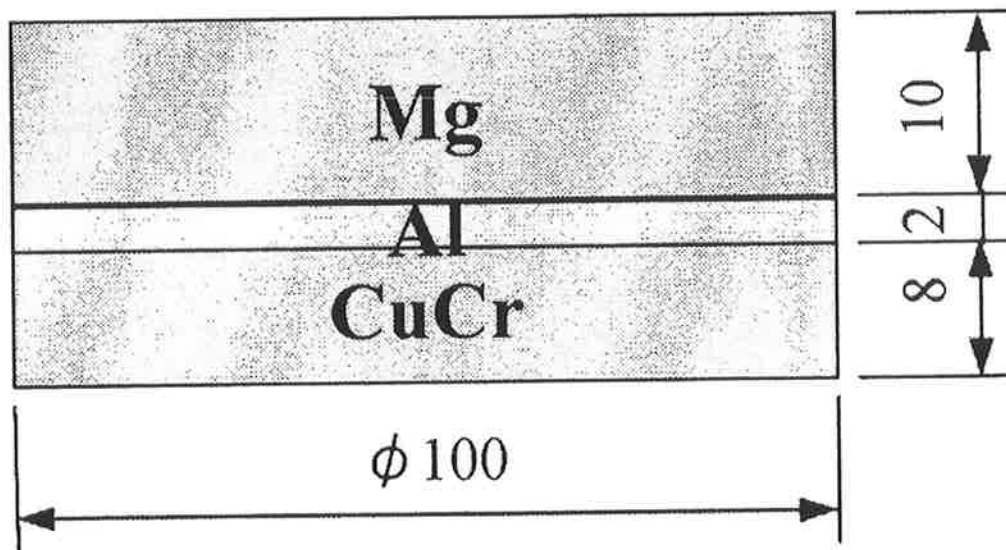
[Fig. 4]

### Cross-Section Structure

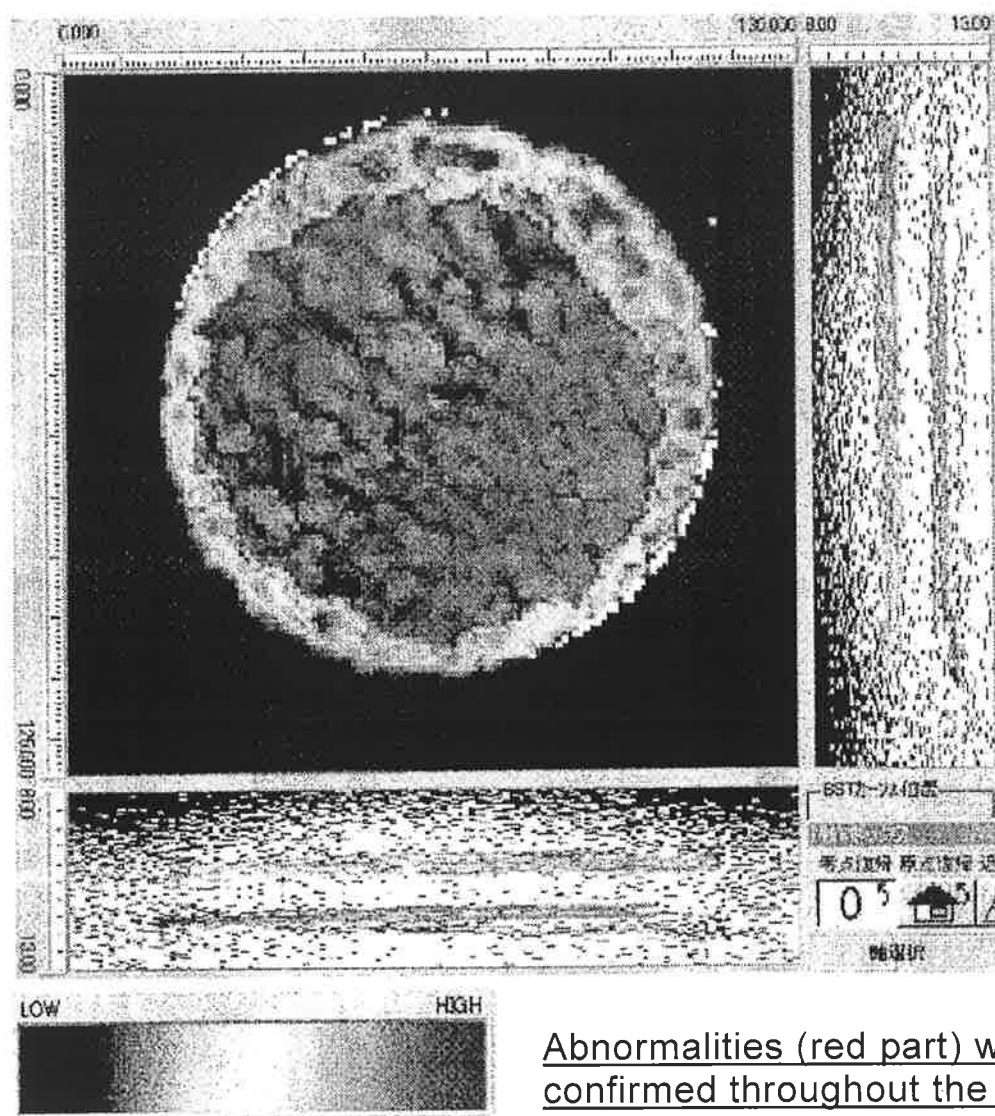
[Fig. 5]

Abnormalities (red part) were confirmed throughout the outer periphery.

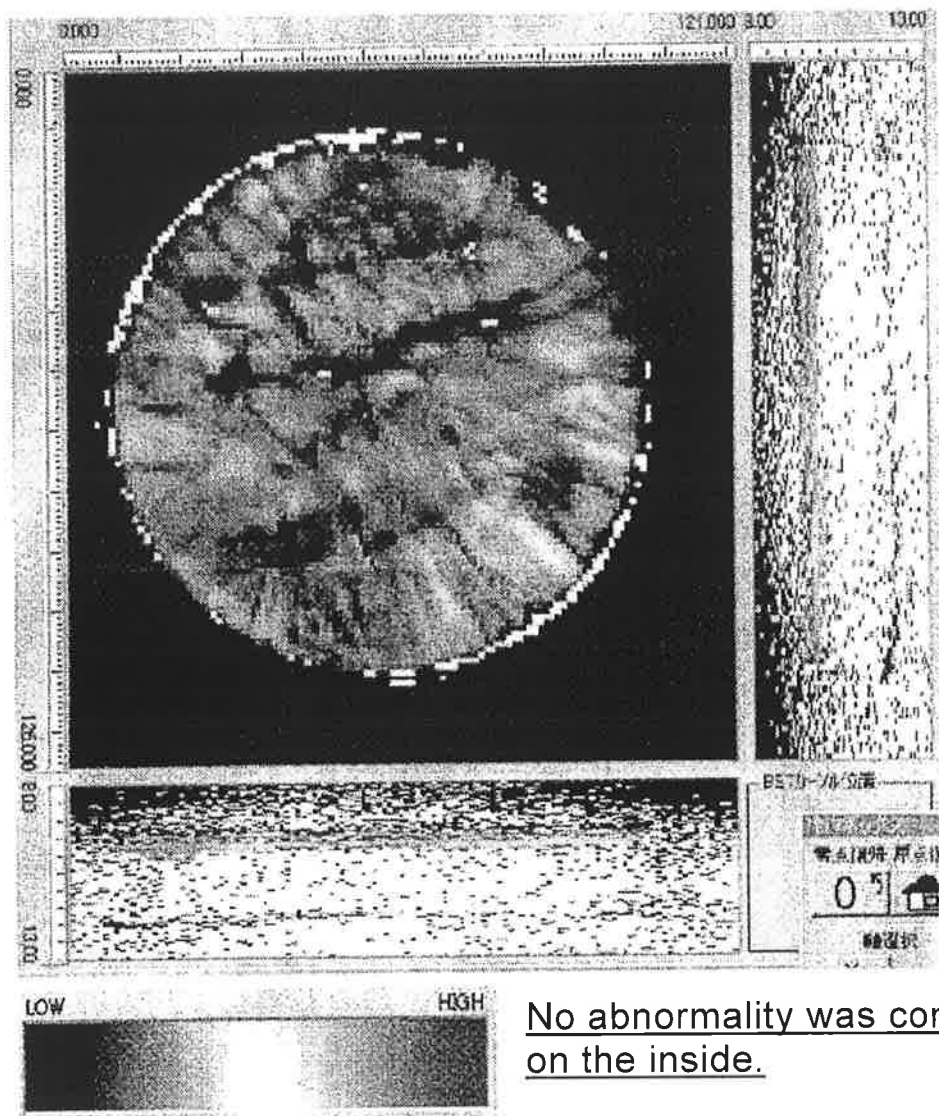
[Fig. 7]

No abnormality was confirmed on the inside.

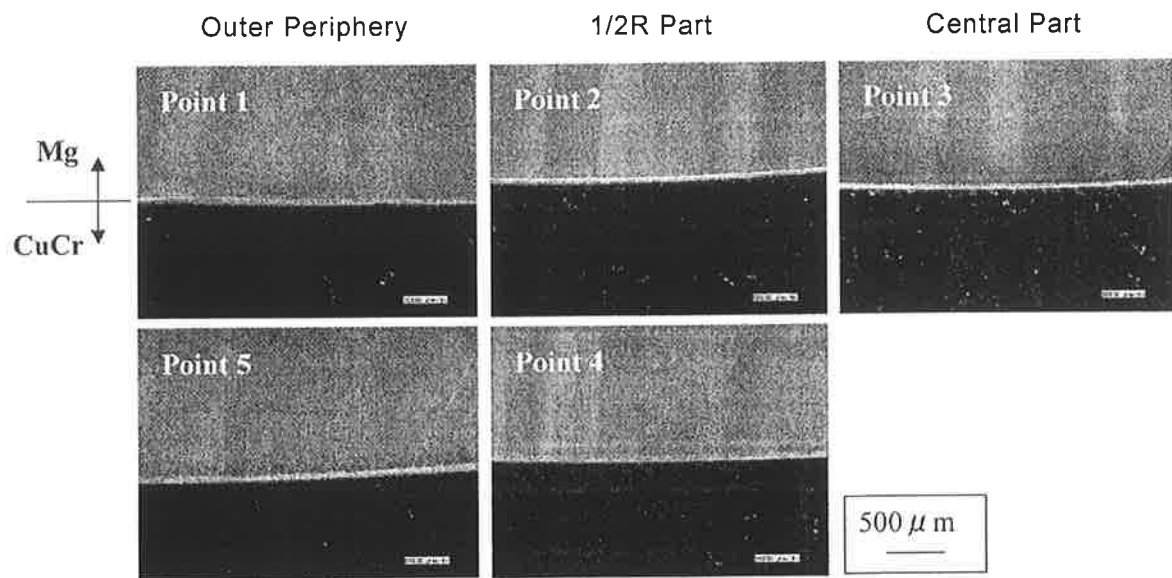
[Fig. 10]

No abnormality such as a gap was acknowledged in the bonded part.
