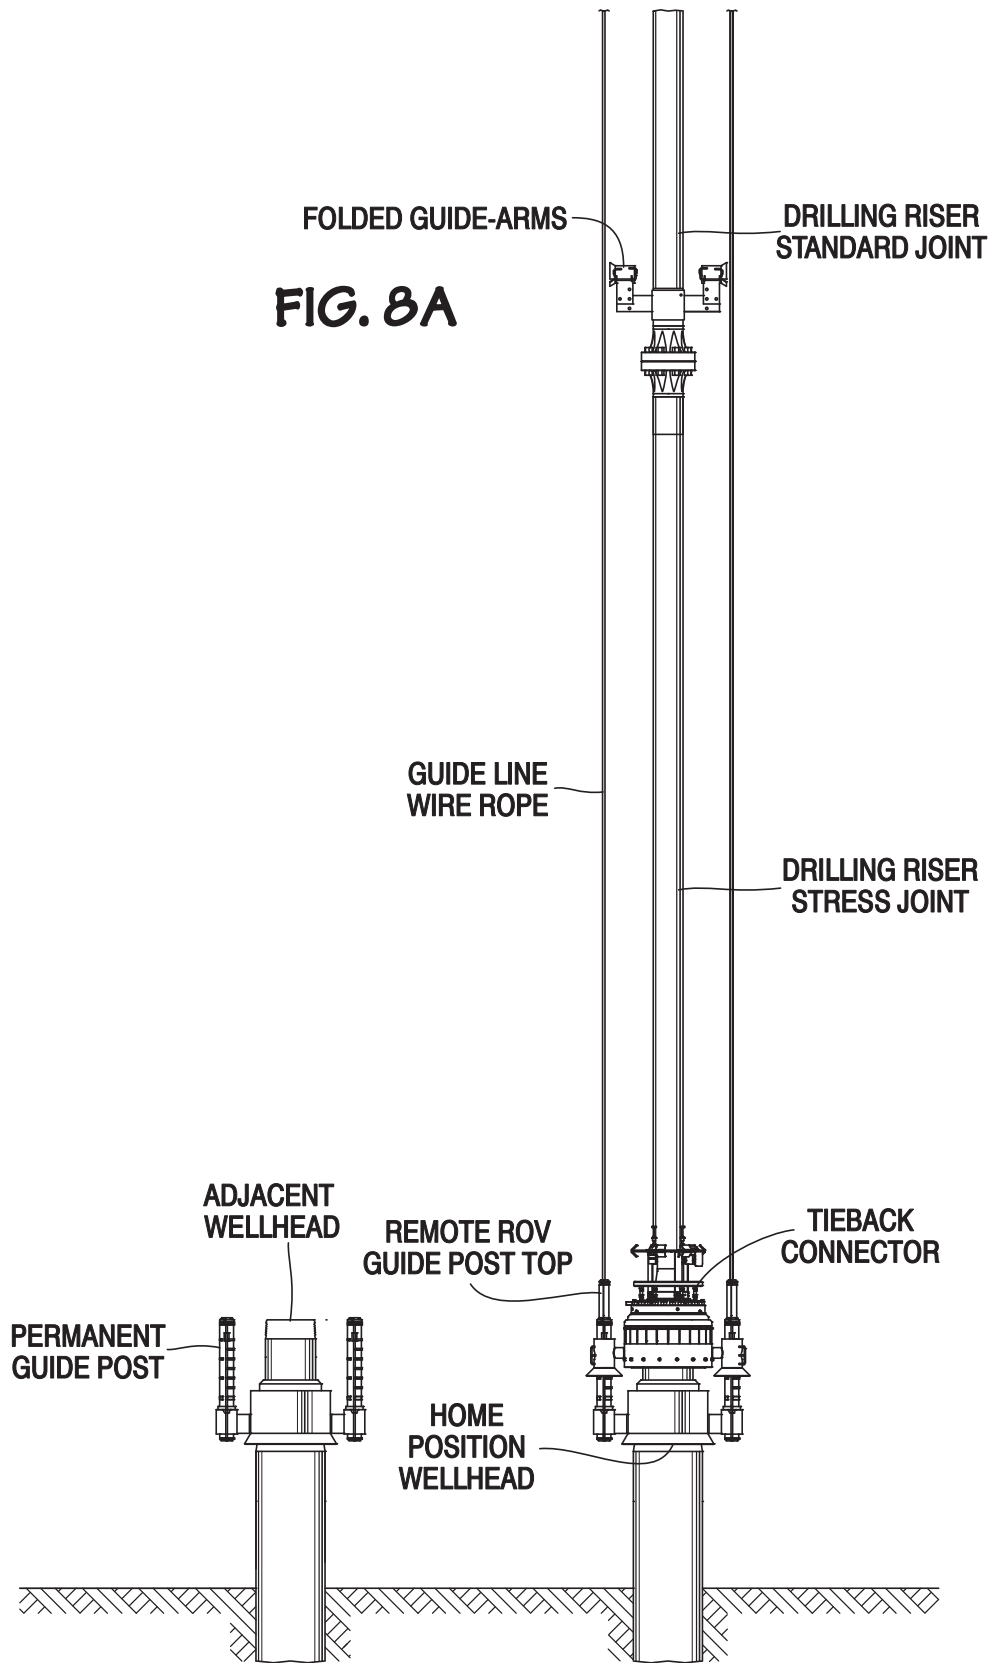
STEP 1: TIEBACK IN HOME POSITION

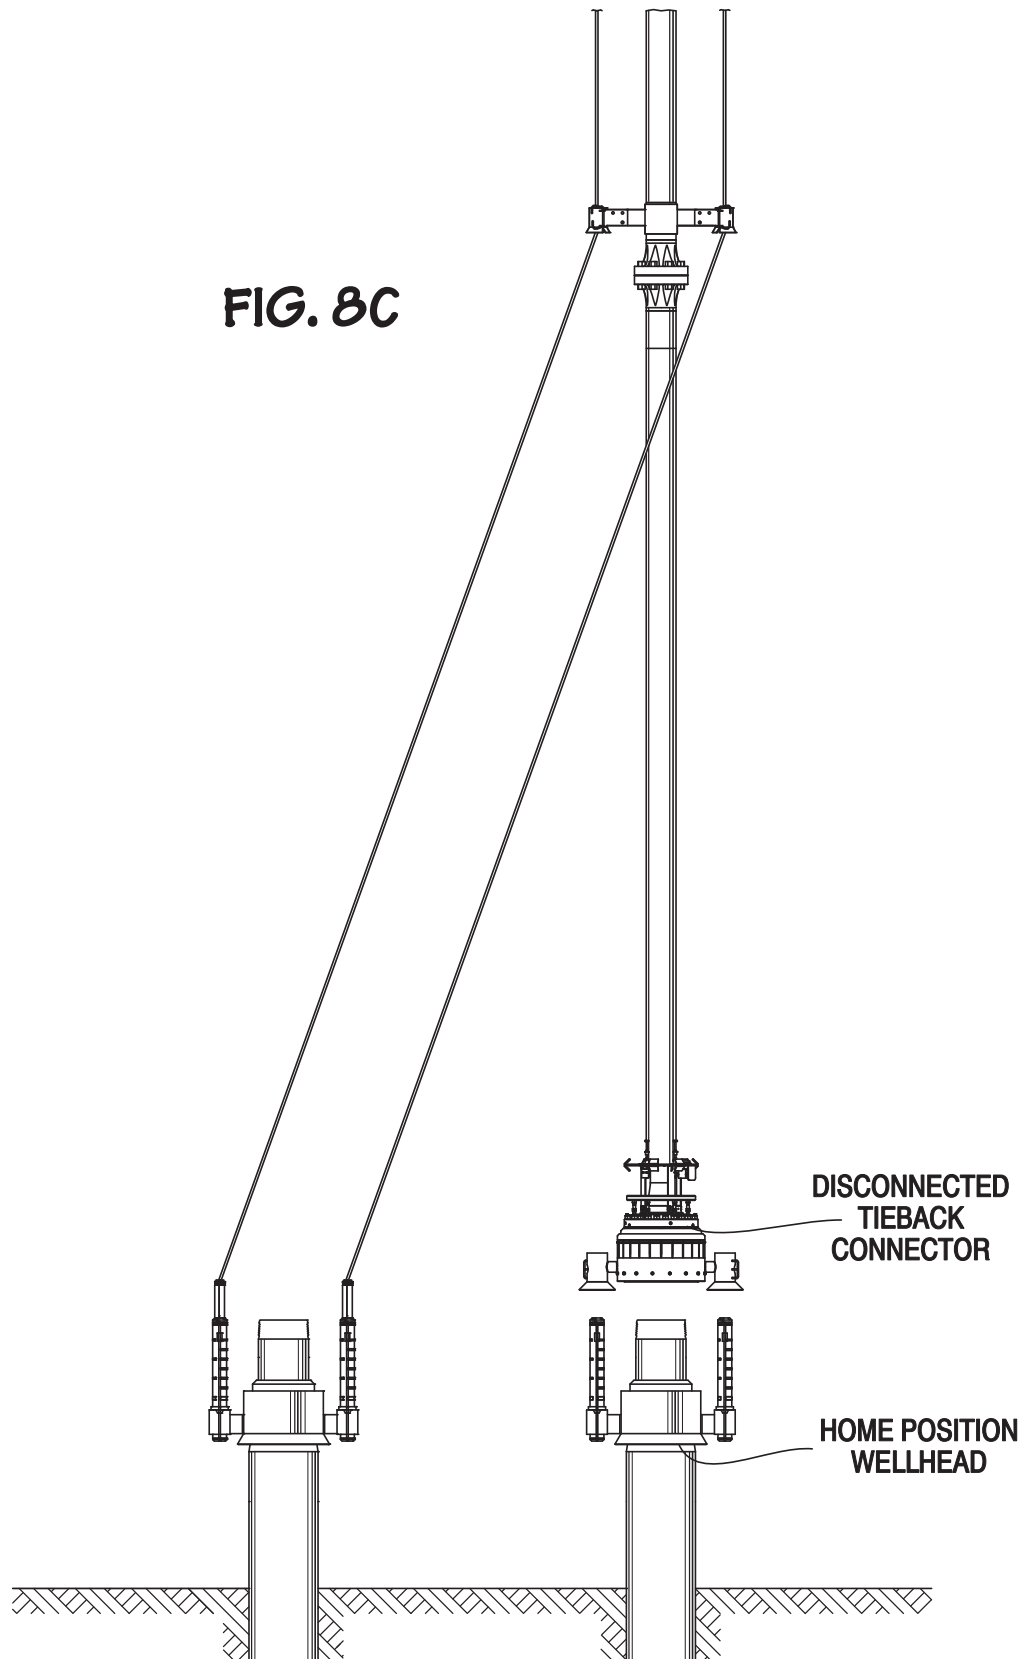
**STEP 3: TIEBACK IS DISCONNECTED FROM HOME POSITION. VERTICAL CLEARANCE BETWEEN TIEBACK AND WELLHEAD IS 2FT.**

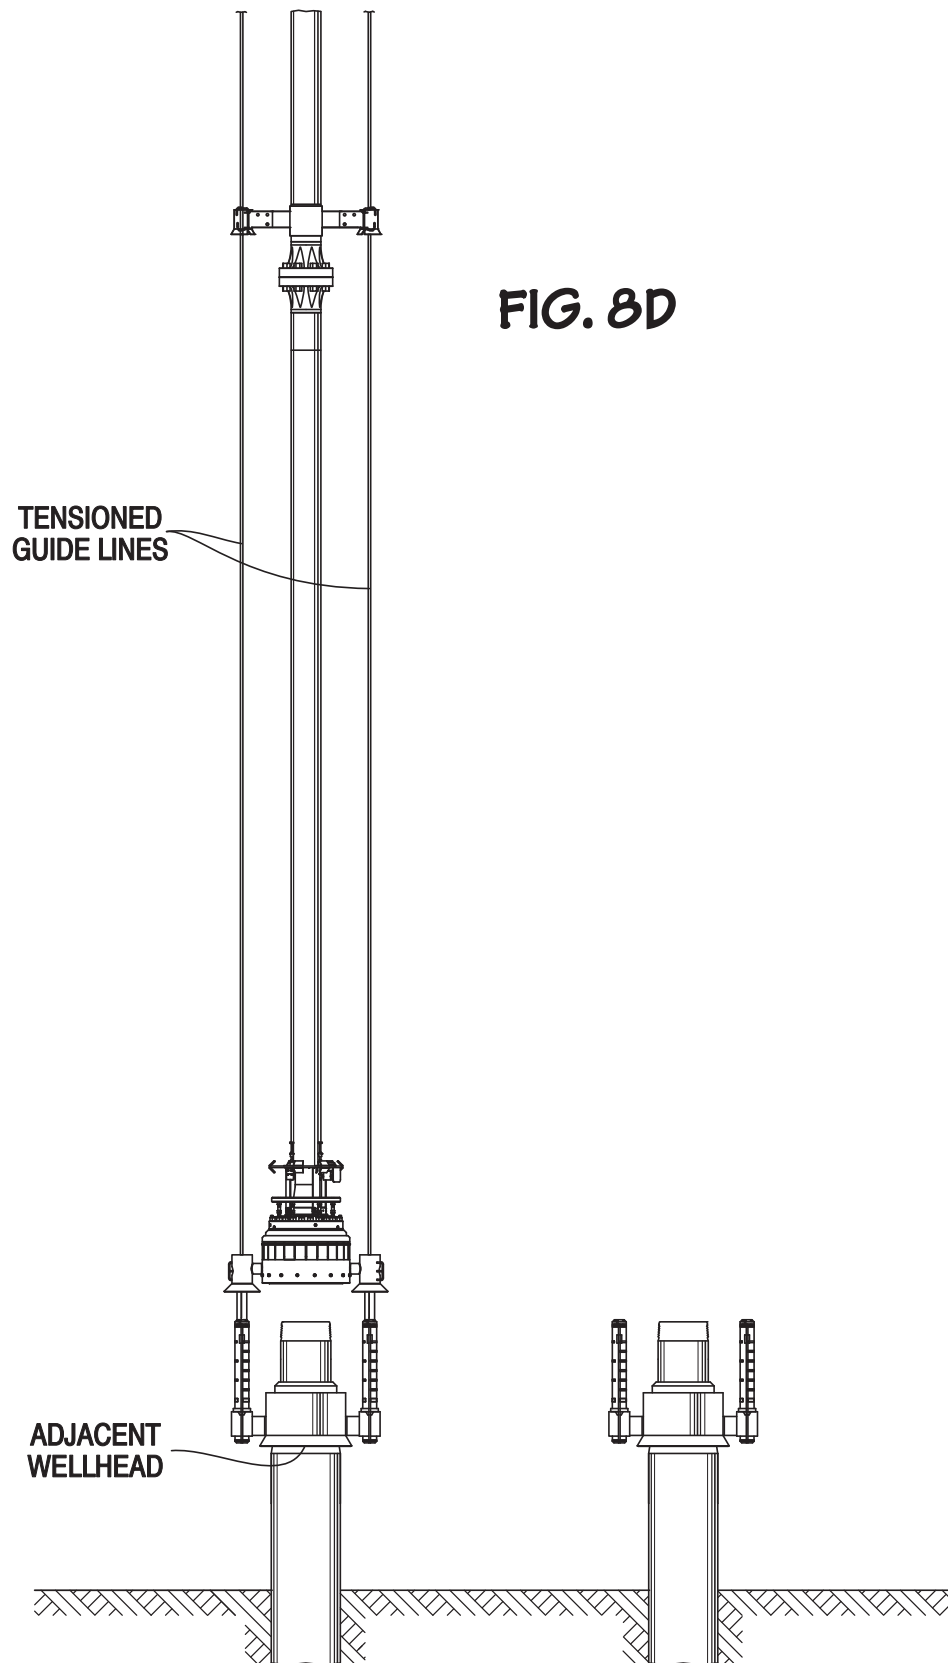
**STEP 4: GUIDE LINES ARE TENSIONED SO THAT TIEBACK  
CONNECTOR MOVES OVER ADJACENT WELL.**

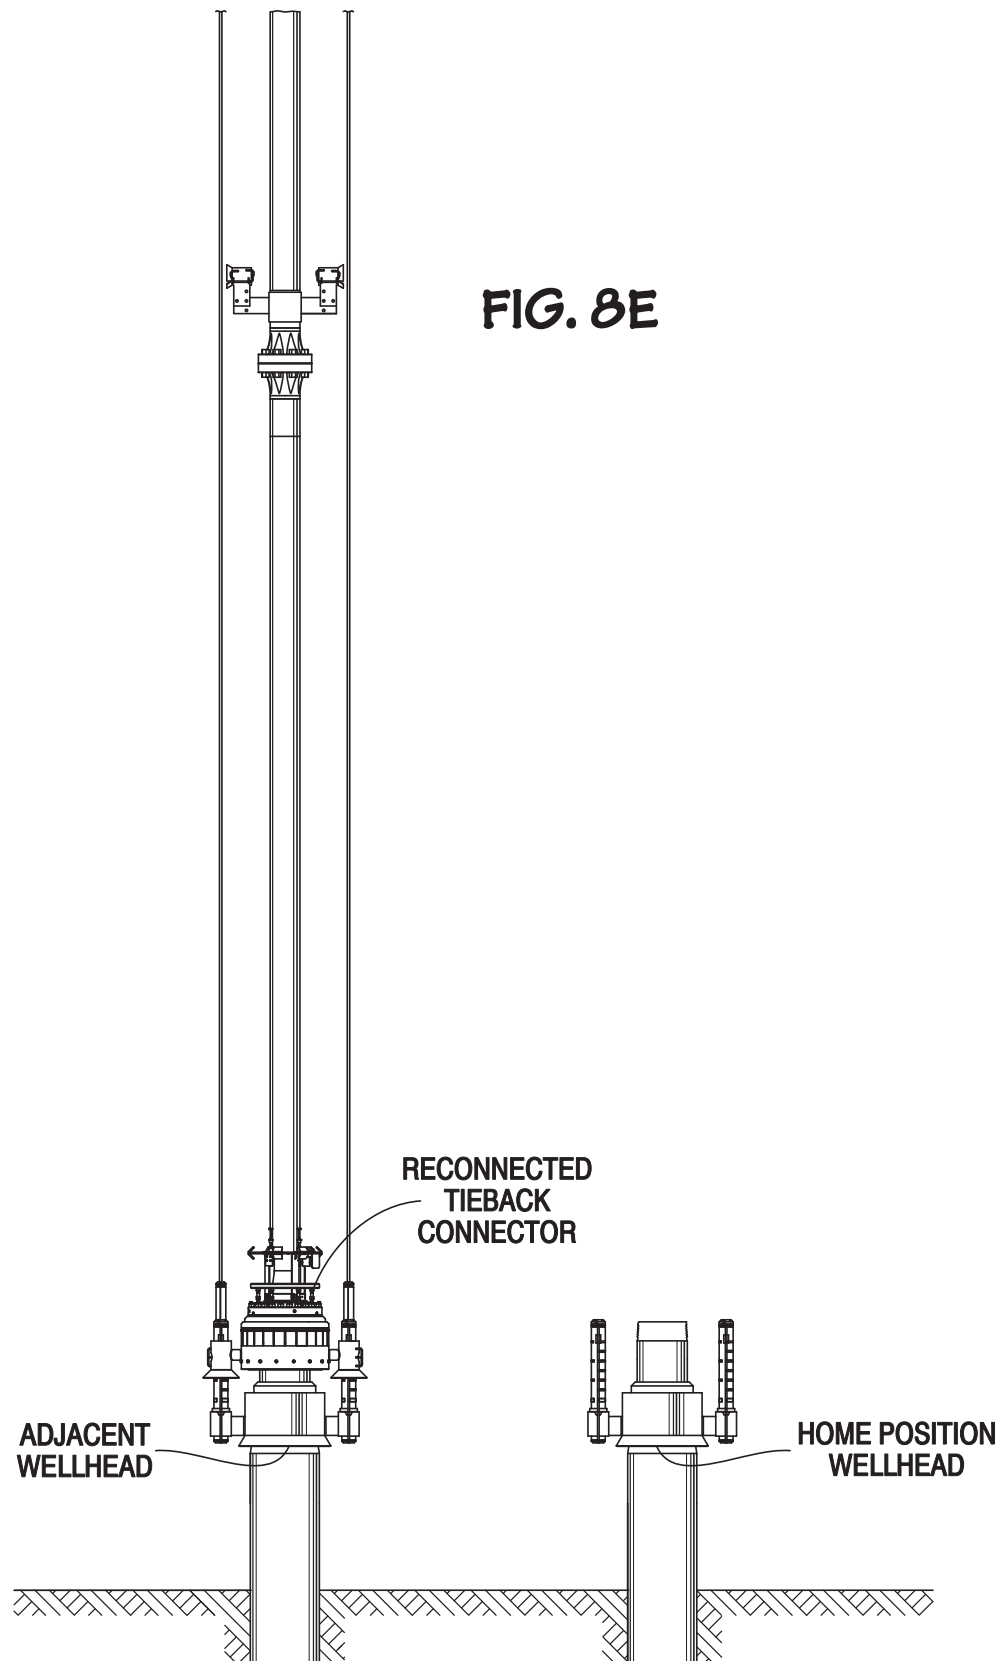
**STEP 5: TIEBACK CONNECTOR LOWERED ONTO WELLHEAD GUIDED BY WIRE ROPES.  
TIEBACK CONNECTOR IS CONNECTED TO WELLHEAD IN ADJACENT POSITION.**
