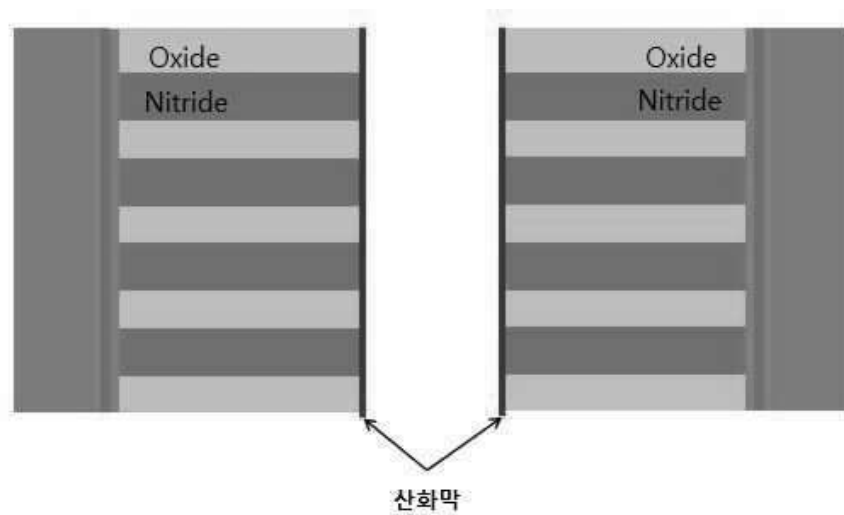
FIG. 2

산화막: Oxide layer

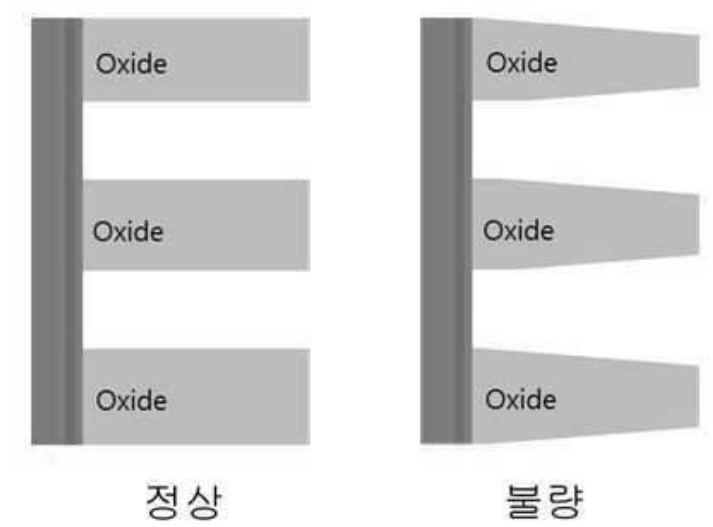
FIG. 3

정상: Normal

불량: Defective

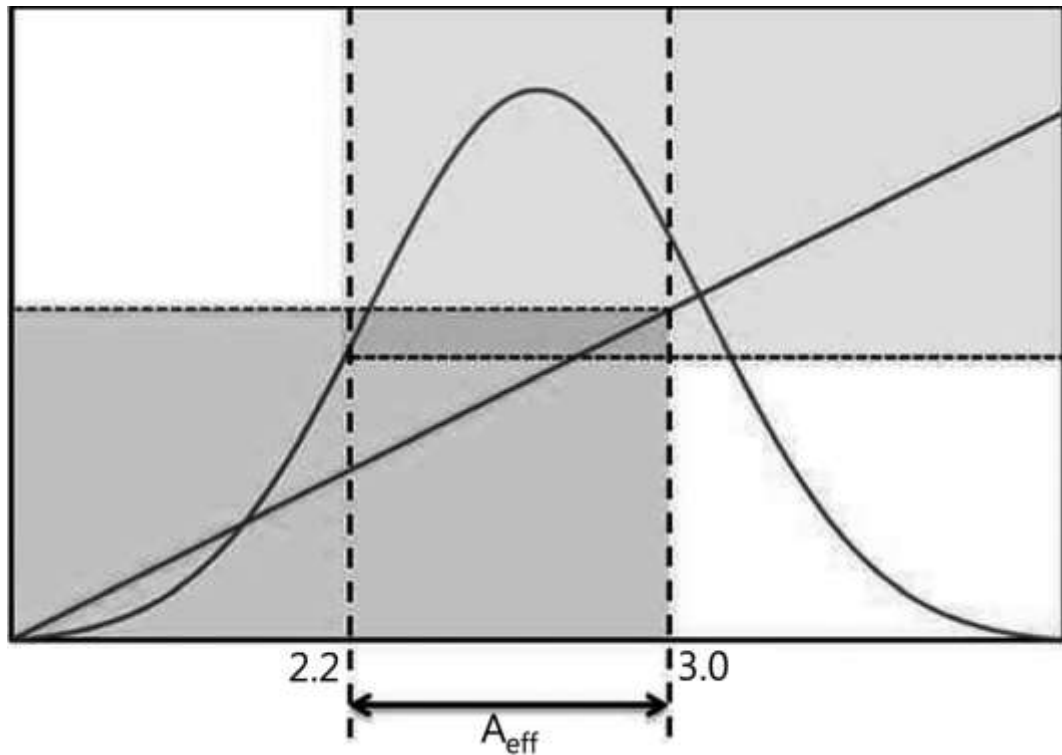
FIG. 4

**x-axis:** the level of  $A_{eff}$  value

**y-axis:**

<left> the time for oxide existed in surface of the layer  
to be removed

<right> the time for occurring damages in oxide layer  
(under layer)
