OXIDATION TEST RESULT OF REPAIRED PORTIONS  
USING VARIOUS REPAIR MATERIALS

LOW CYCLE FATIGUE STRENGTH OF REPAIRED PORTIONS  
REPAIRED BY USING VARIOUS REPAIR MATERIALS

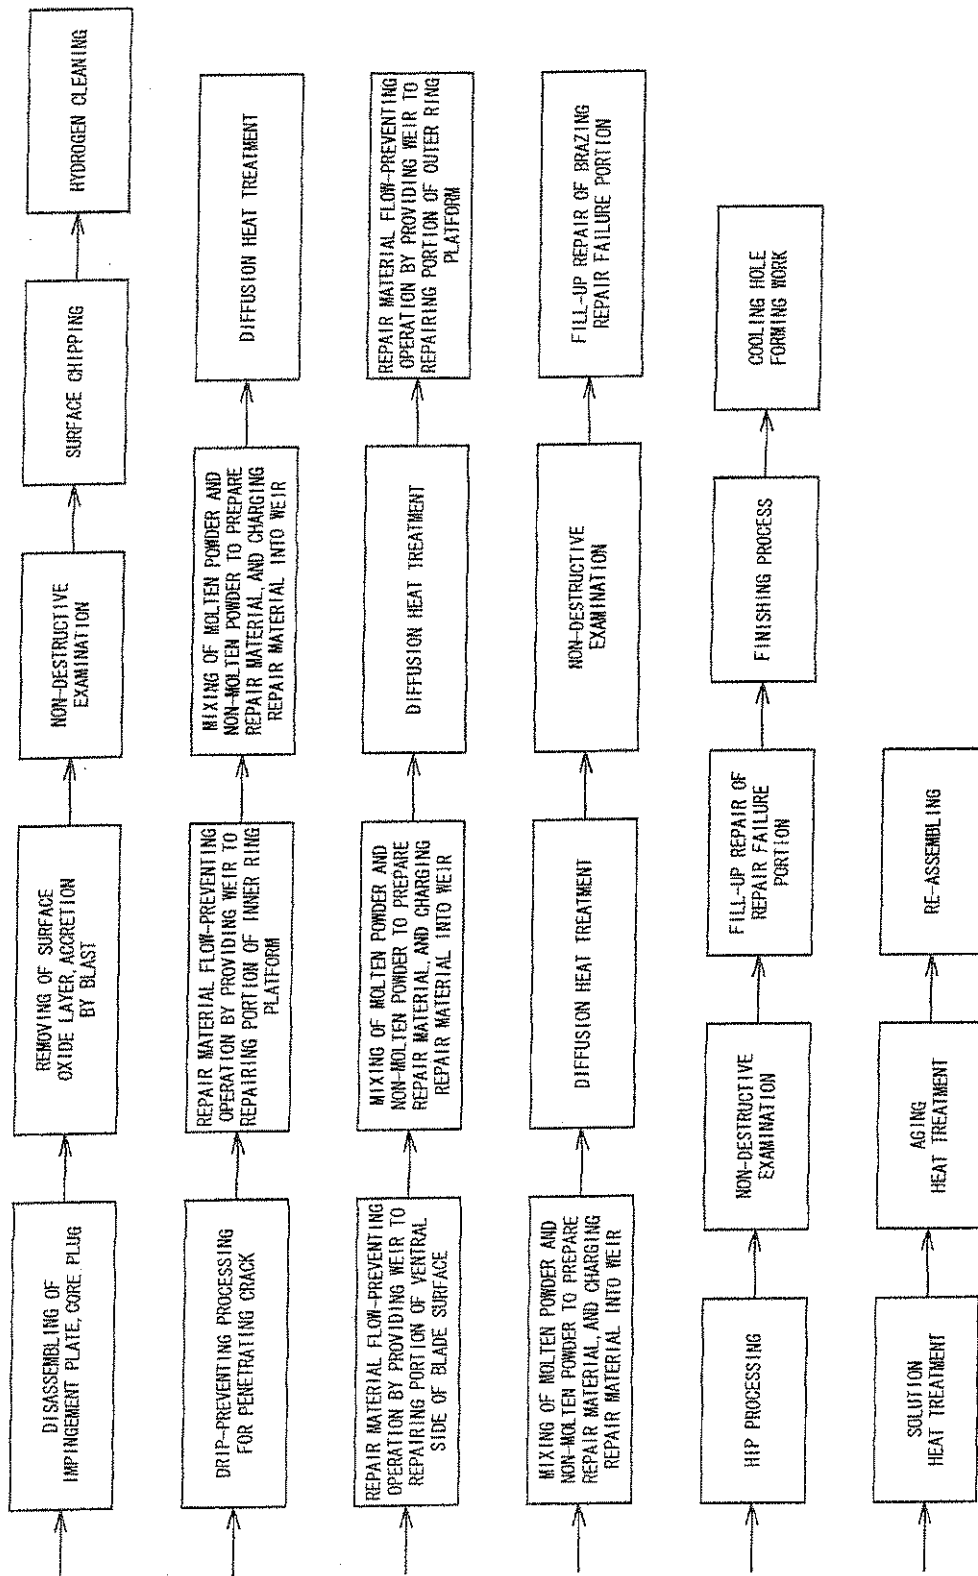
FIG. 4

EXAMPLE OF CONDUCTING PROCESS OF PERFORMING REPAIR TECHNIQUE  
USING BRAZING REPAIR MATERIAL

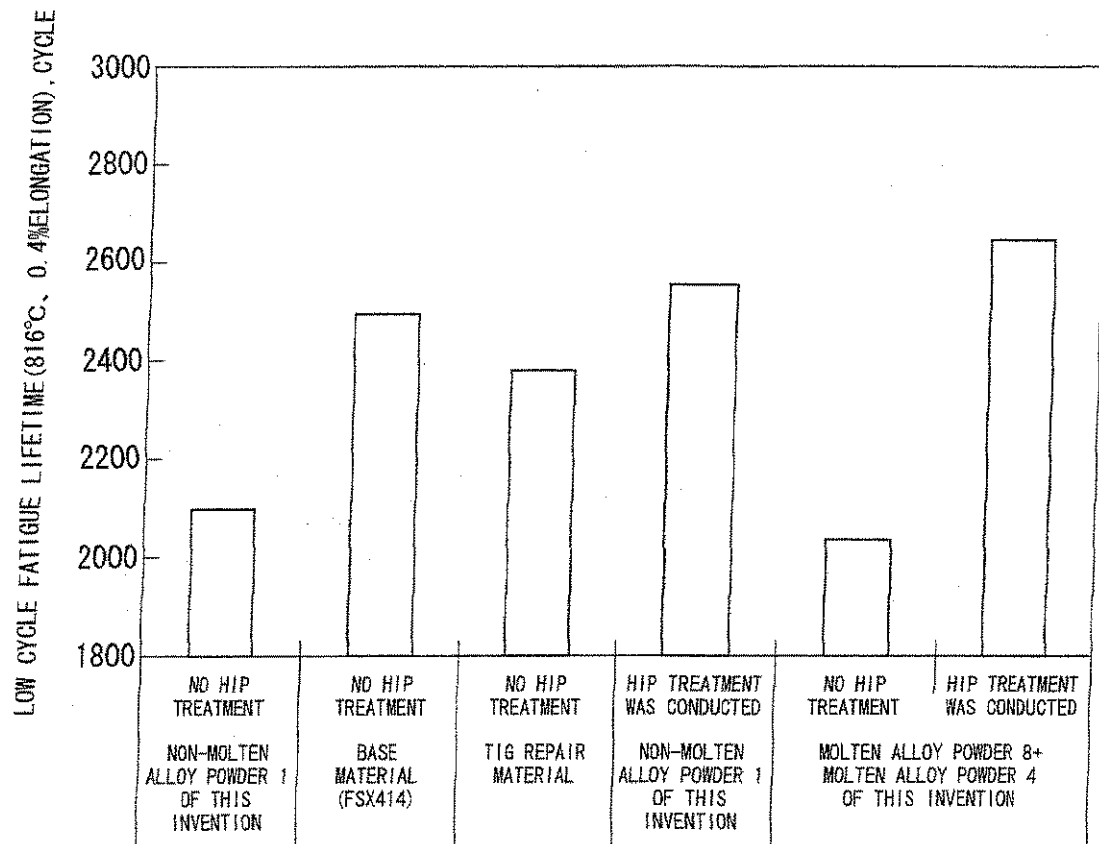
FIG. 5

EFFECT OF IMPROVING LOW CYCLE FATIGUE STRENGTH  
BY CONDUCTING HIP TREATMENT

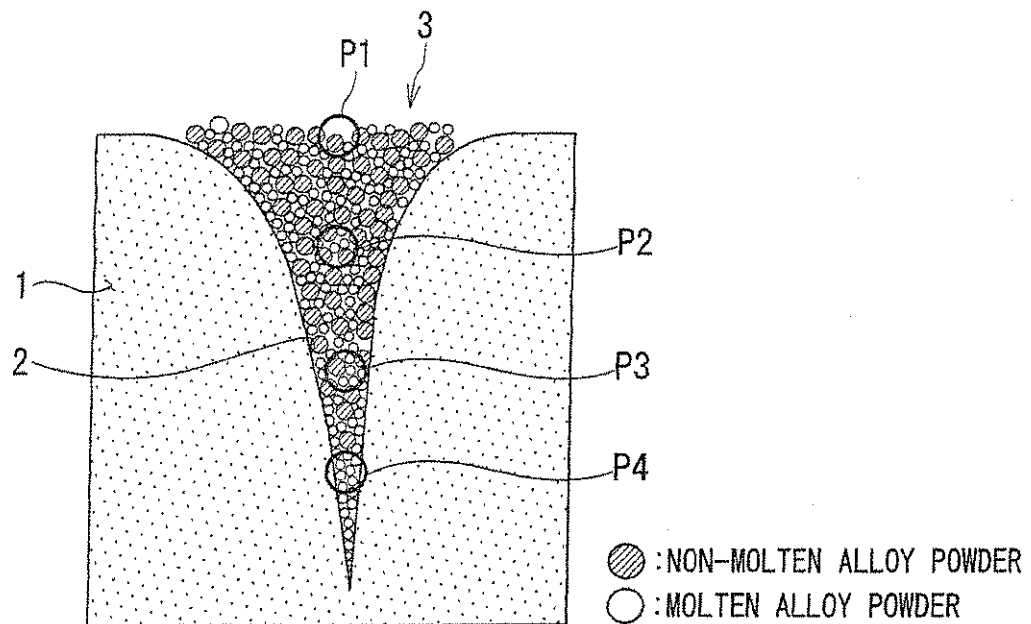
FIG. 6

DISTRIBUTION STATE OF REPAIRED PORTION AFTER  
PERFORMING DIFFUSION BRAZING HEAT TREATMENT  
USING NON-MOLTEN ALLOY AND MOLTEN ALLOY

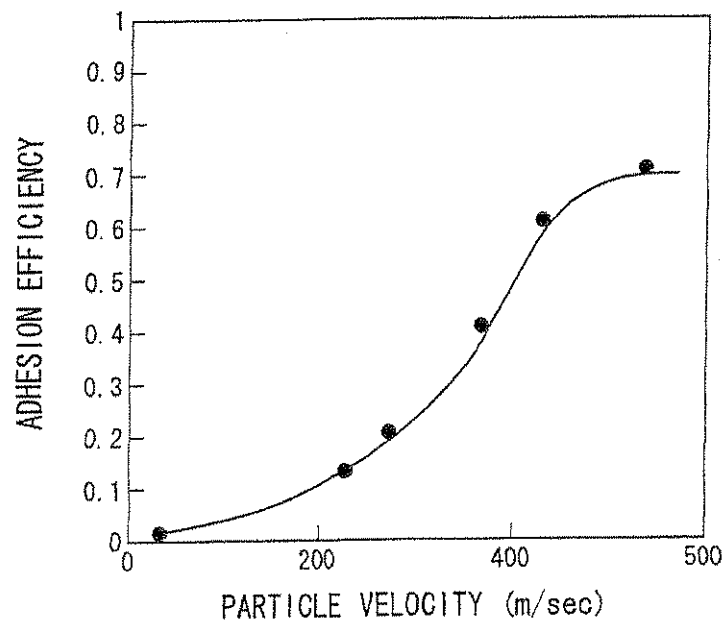
FIG. 8

RELATIONSHIP BETWEEN PARTICLE VELOCITY AND  
ADHESION EFFICIENCY IN NON-MOLTEN COATING APPARATUS

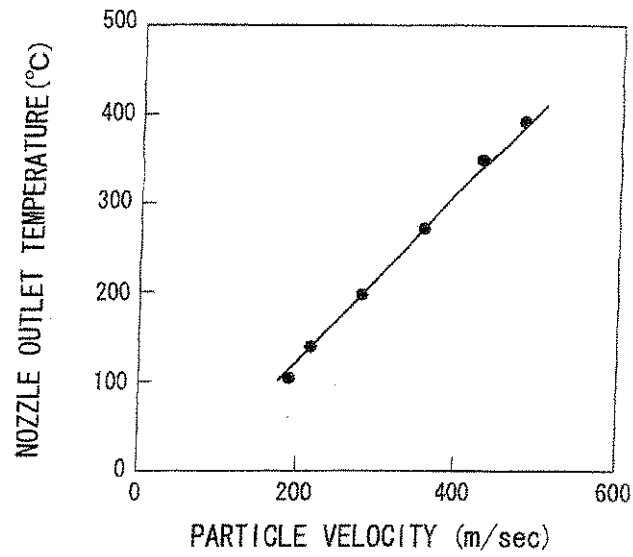
FIG. 9

RELATIONSHIP BETWEEN PARTICLE VELOCITY AND NOZZLE  
OUTLET TEMPERATURE IN NON-MOLTEN COATING APPARATUS

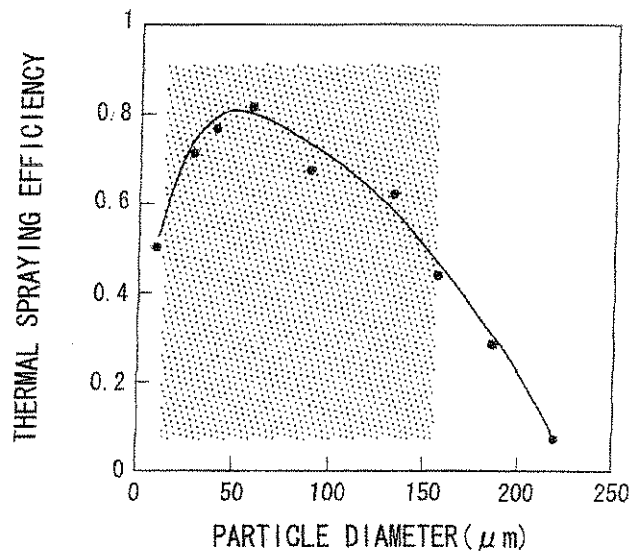
FIG. 10

RELATIONSHIP BETWEEN PARTICLE DIAMETER AND THERMAL  
SPRAYING EFFICIENCY IN NON-MOLTEN COATING APPARATUS
