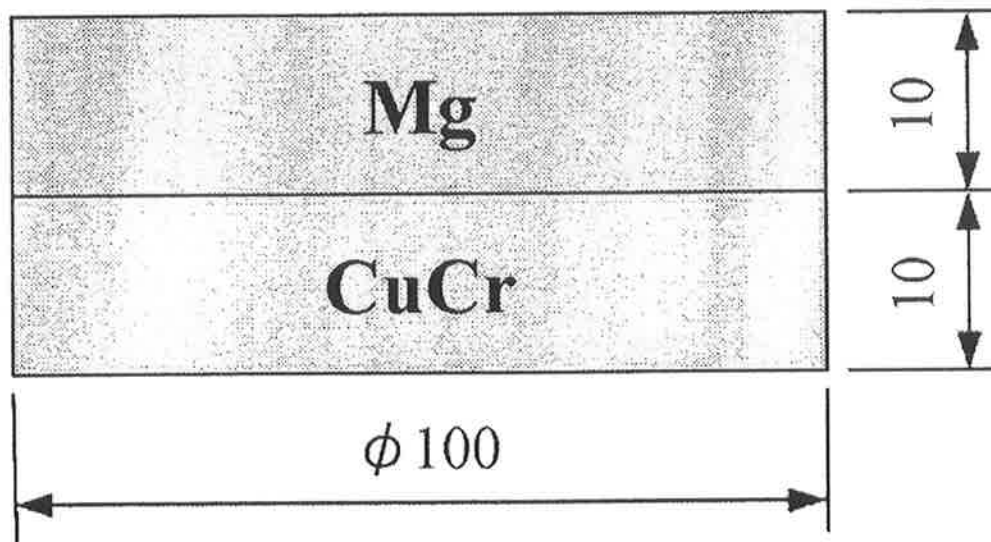
[Fig. 1]

### Cross-Section Structure

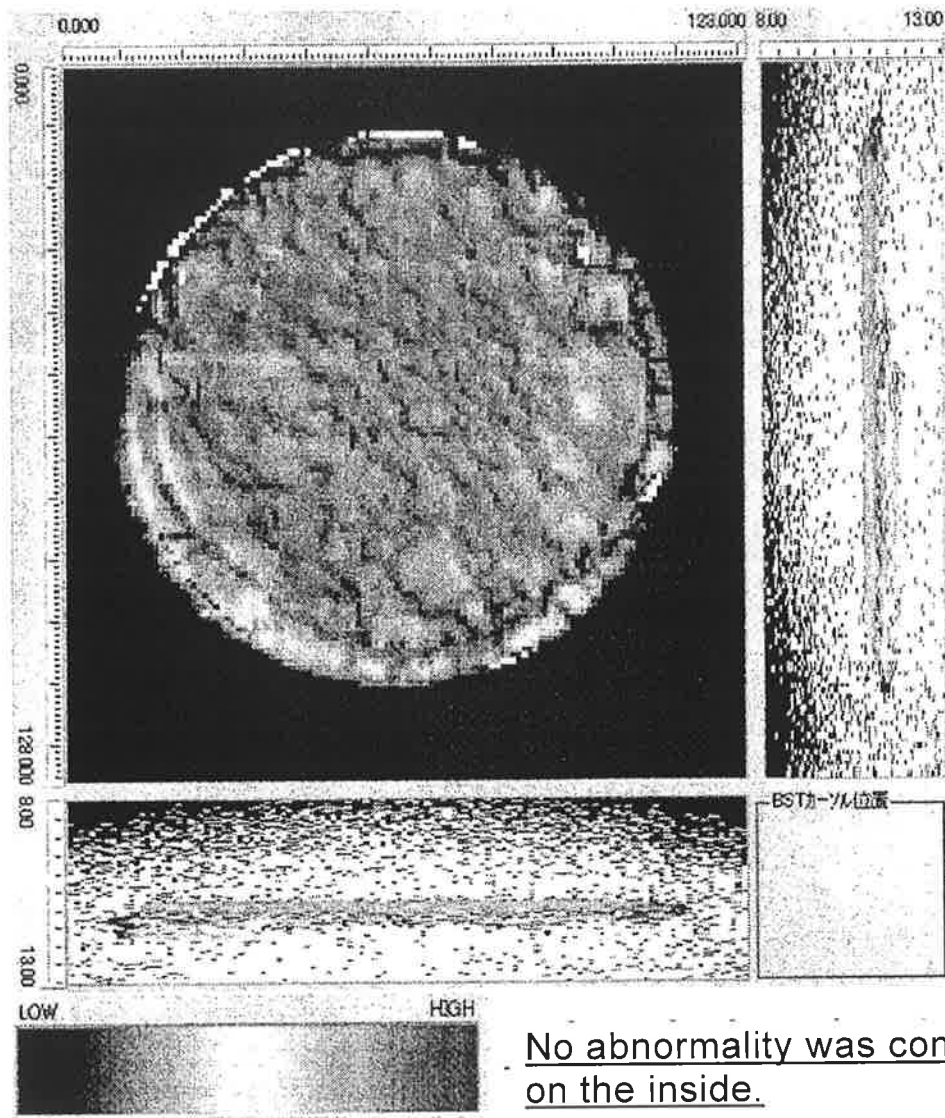
[Fig. 2]

No abnormality was confirmed on the inside.

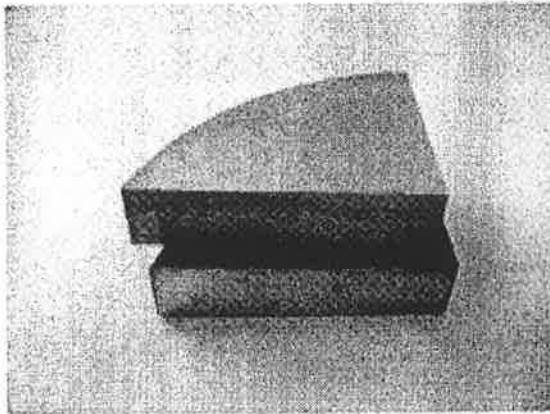
[Fig. 3]

Peeling occurred during the processing.

→ It is because these are not bonded or the bond strength is weak.

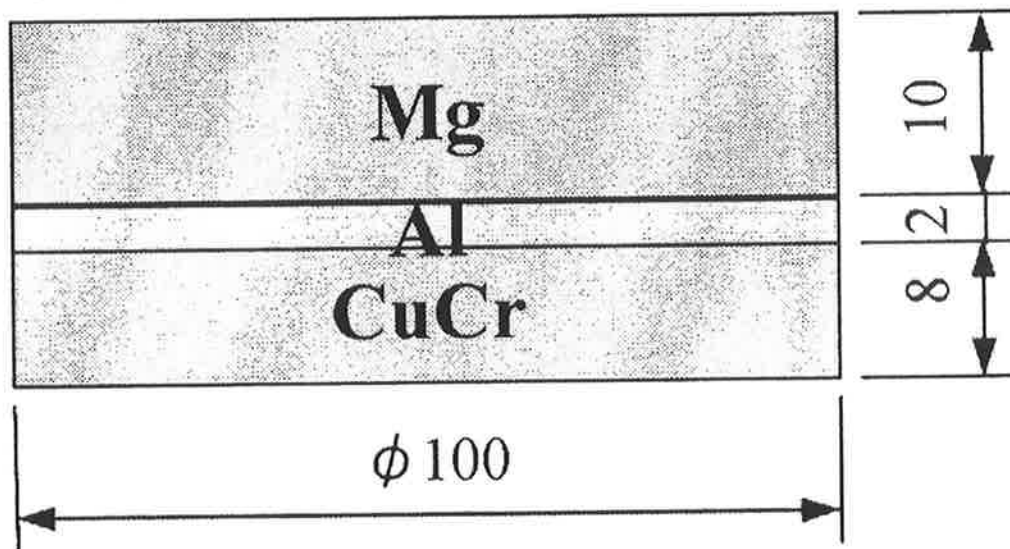
[Fig. 4]

### Cross-Section Structure

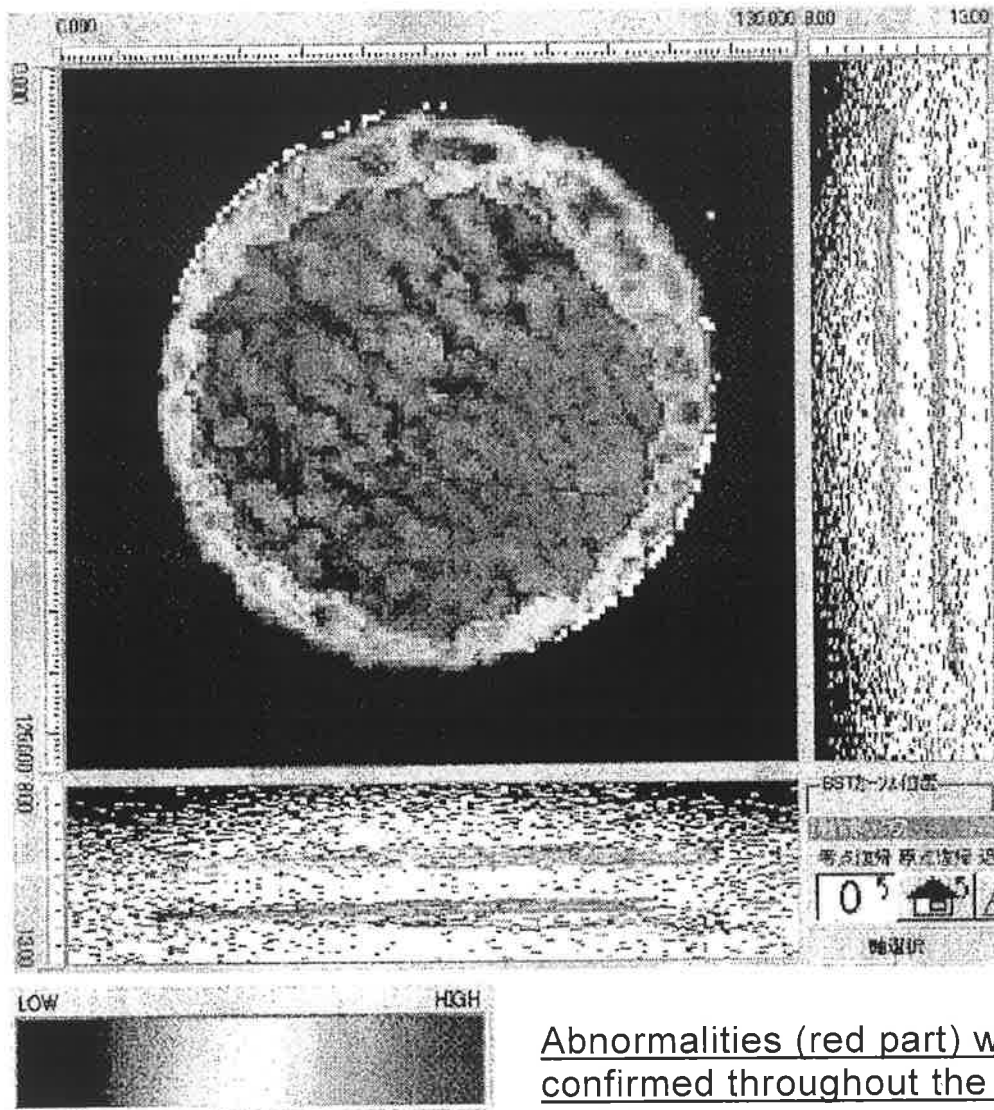
[Fig. 5]

Abnormalities (red part) were confirmed throughout the outer periphery.

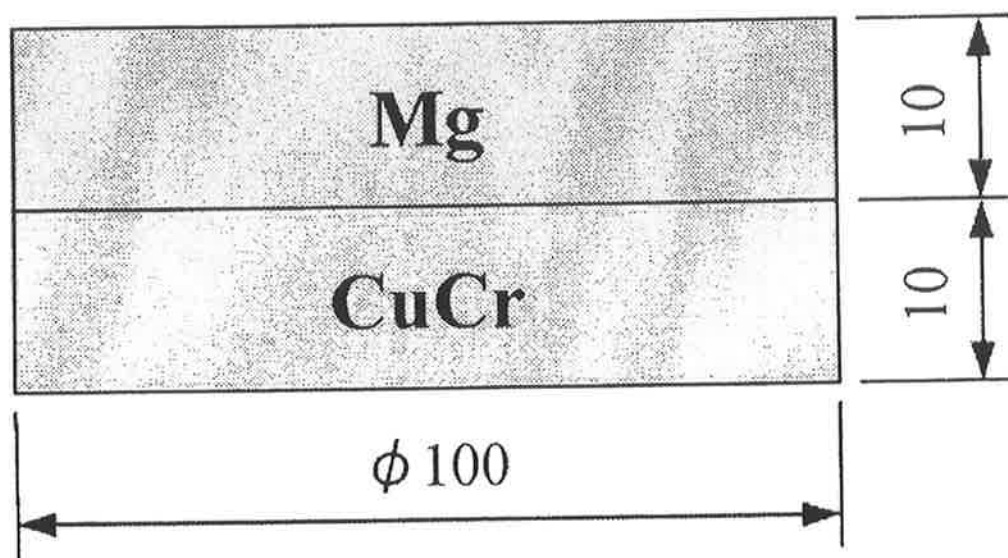
[Fig. 6]

## Cross-Section Structure

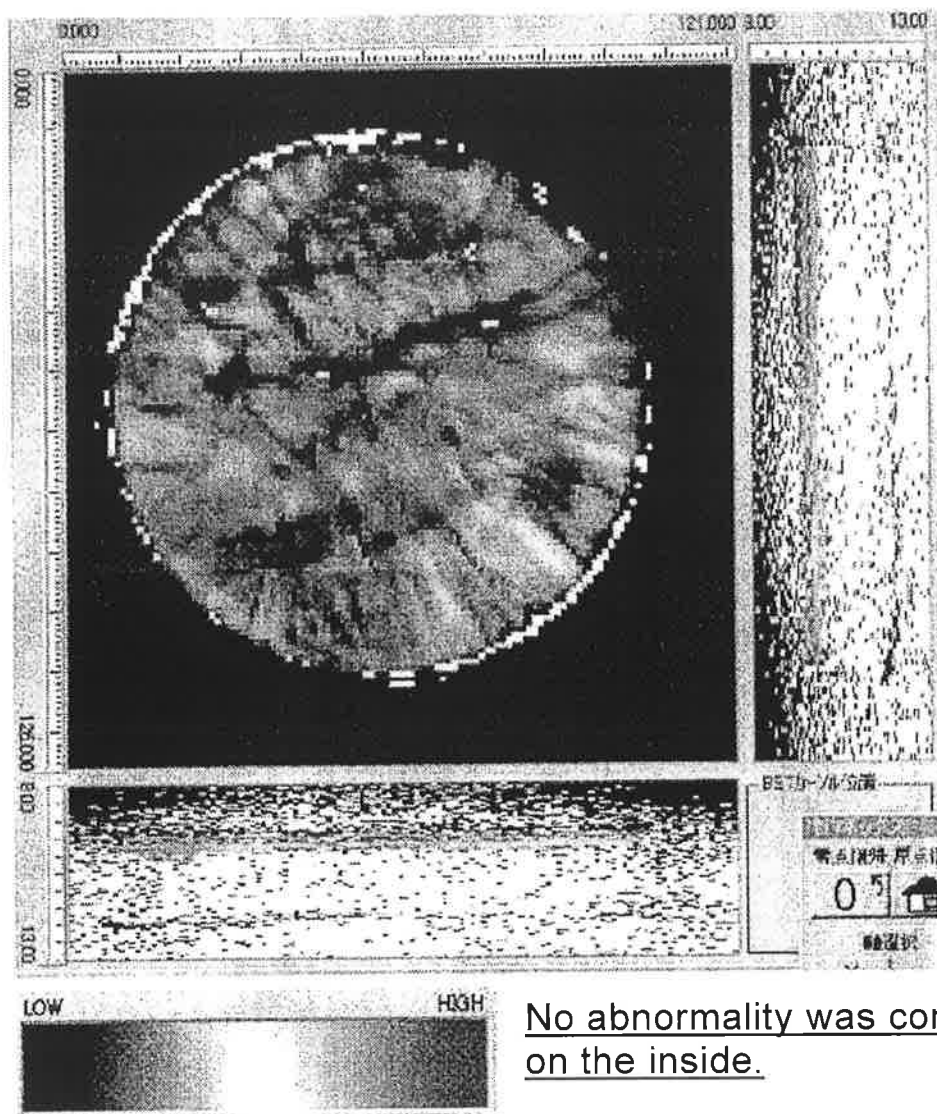
[Fig. 7]

No abnormality was confirmed on the inside.

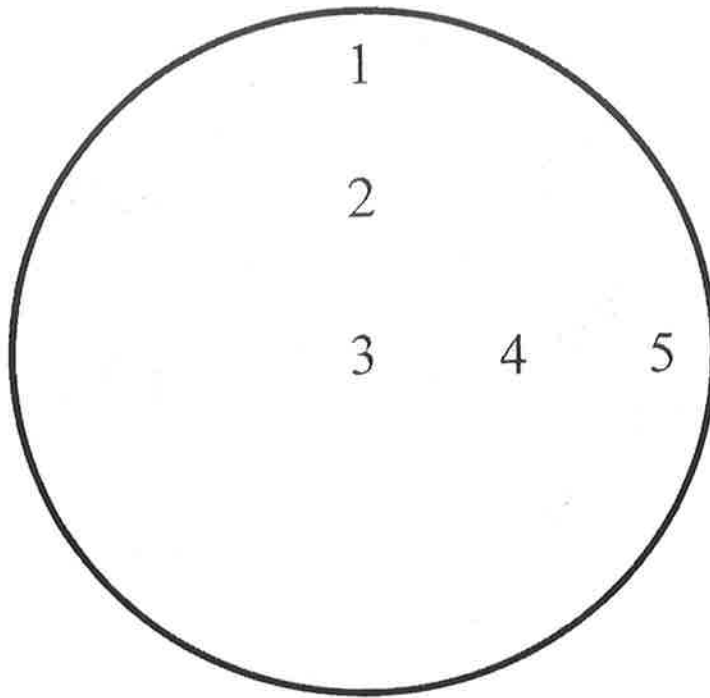
[Fig. 8]

## Sampled Locations

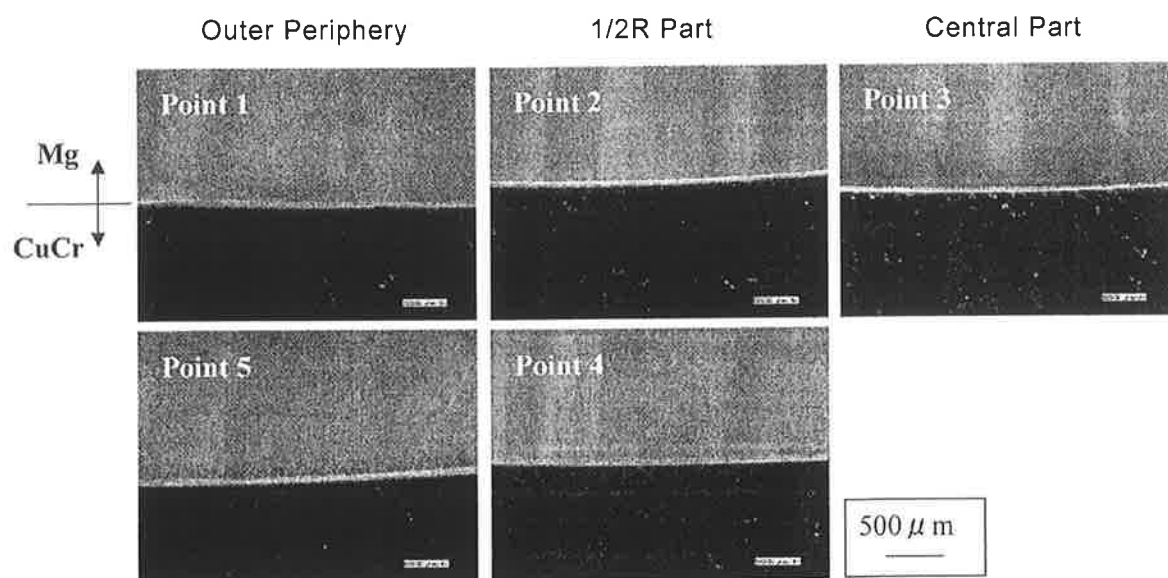
[Fig. 10]

No abnormality such as a gap was acknowledged in the bonded part.
