**FIGURES FOR TECHNIQUES FOR MAINTAINING A SUBSTRATE PROCESSING SYSTEM**

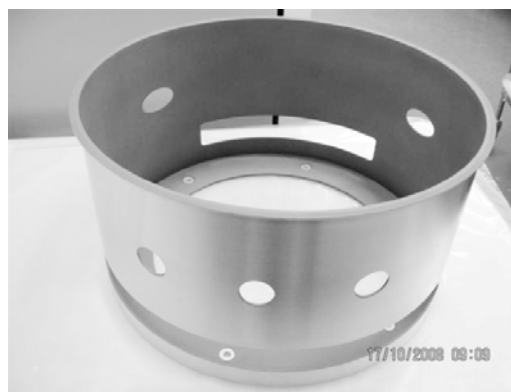
FIGURE 14A shows exemplary used silicon coated chamber shield liner before recovery, while FIGURE 14B shows exemplary silicon coated chamber shield liner after recovery. Dark stained regions in Figure 14A are no longer observed after recovery as seen in Figure 14B.

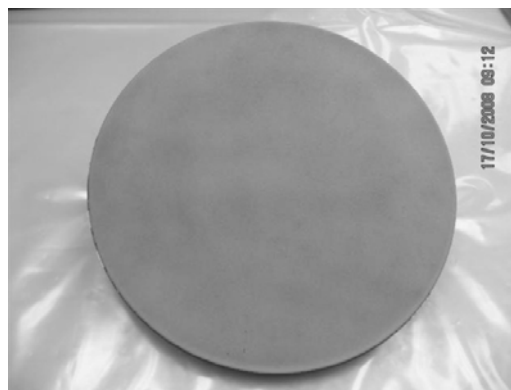
FIGURE 15A shows exemplary used silicon coated baffle cooling plate before recovery, while FIGURE 15B shows exemplary silicon coated baffle cooling plate after recovery. Dark stained regions in Figure 15A are no longer observed after recovery as seen in Figure 15B.
