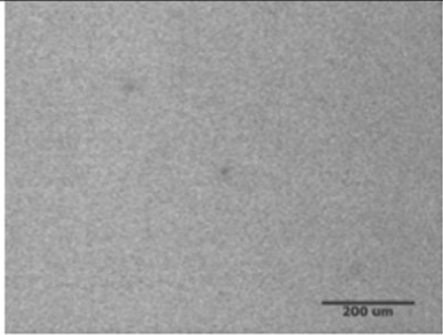
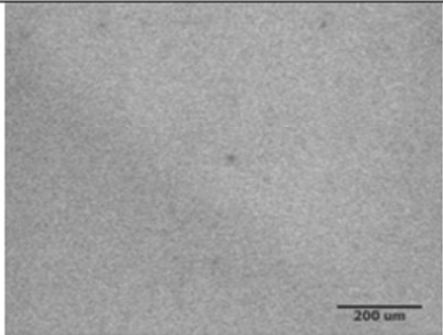
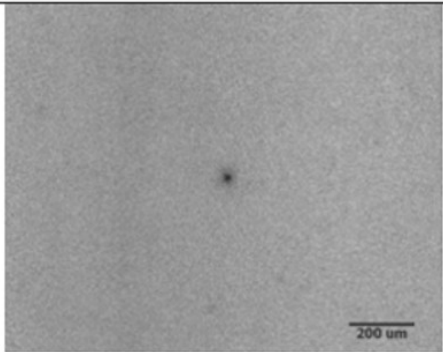
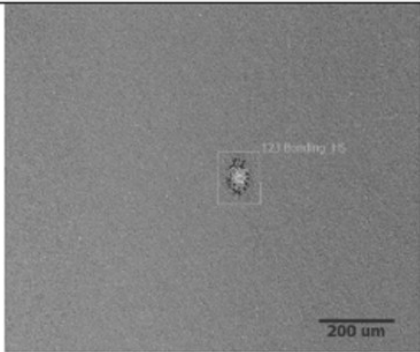
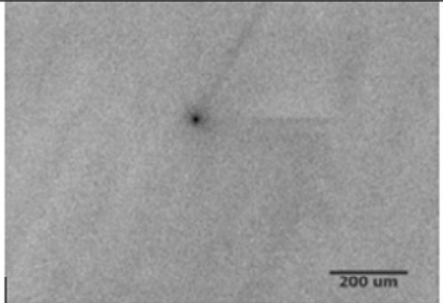
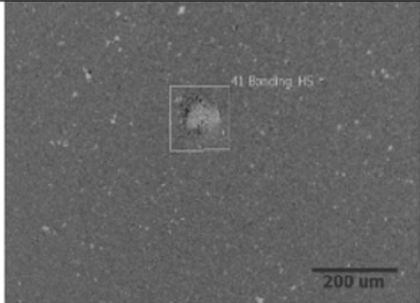
[Fig. 2b]

| Photoluminescence image of the primary defect (donor substrate) | Contrast | Optical microscopy image of the secondary defect (thin film of the composite structure) |

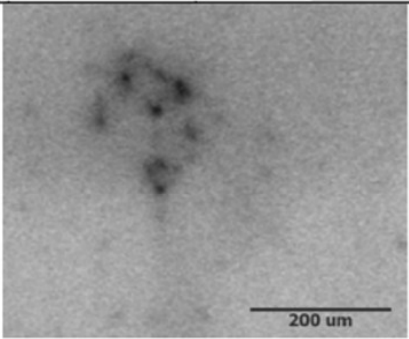
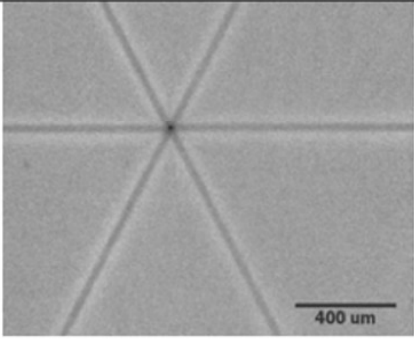
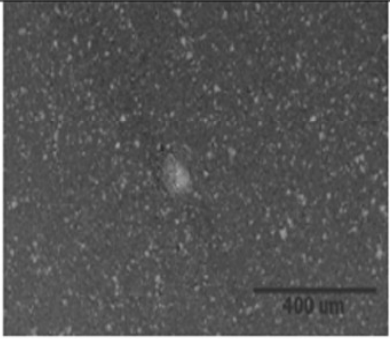
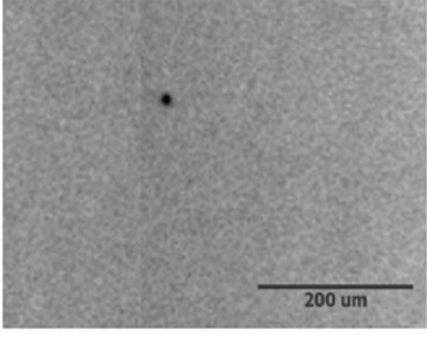
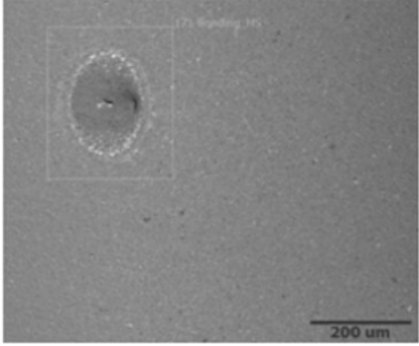
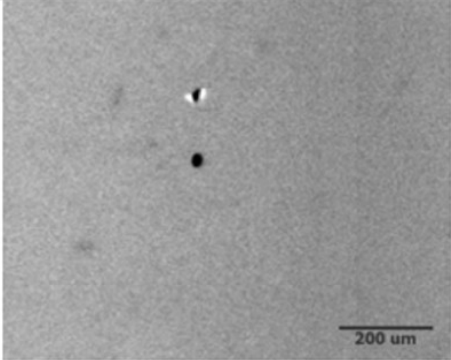
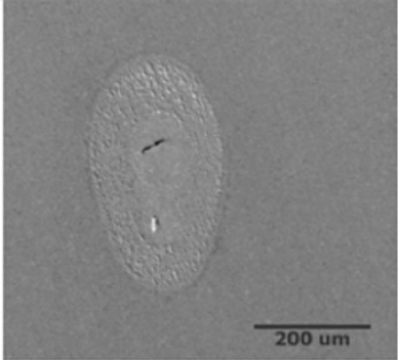
[Fig. 2c]

| Photoluminescence image<br>of the primary defect<br>(donor substrate) | Contrast | Optical microscopy image<br>of the secondary defect<br>(thin film of the composite structure) ) |

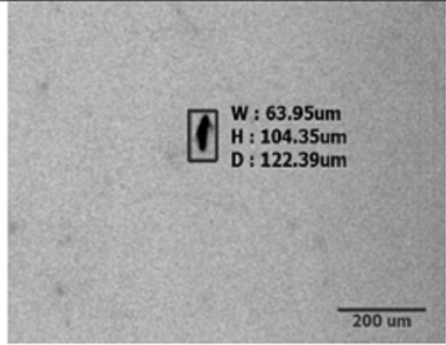
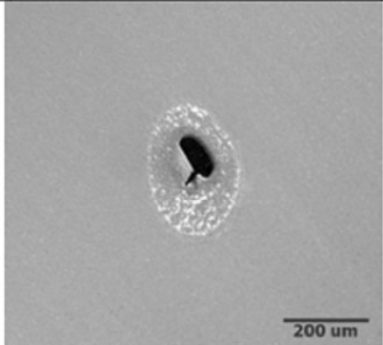
[Fig. 2d]

| Photoluminescence image of the primary defect (donor substrate) | Contrast | Optical microscopy image of the secondary defect (thin film of the composite structure) |
