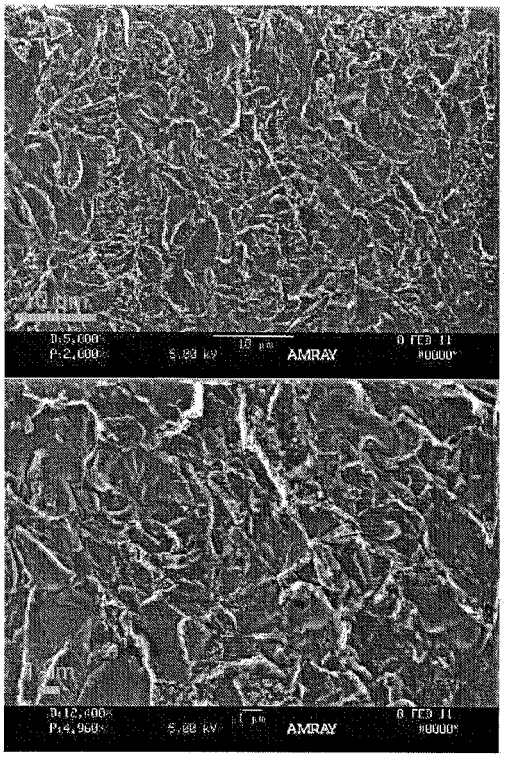
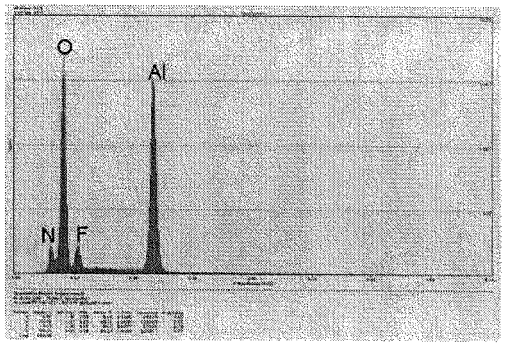
N	O	F	Al
At. %	8.9	42.2	5.7	43.2

- Coating delaminates between barrier layer and quartz substrate.
- Relatively low concentration of fluorine on backside of coating may indicate that corrosion started from frontside of coating.

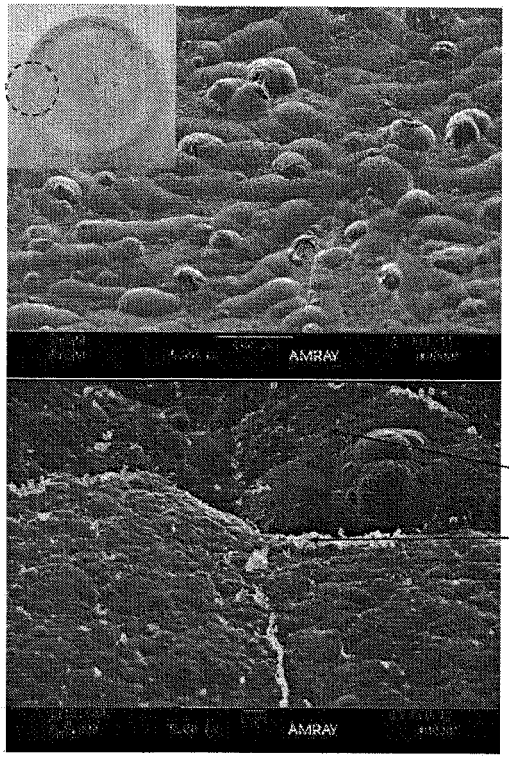
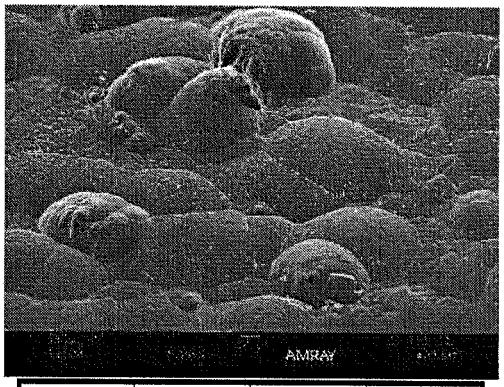
FIG. 2

At. %	O	F	Si
Area 1	44.7	1.7	53.6
Area 2	42.2	6.7	51.1

- Exposed quartz substrate exhibits cauliflower-type of micron-size structures.
- Fluorine-rich species detected along the boundaries.

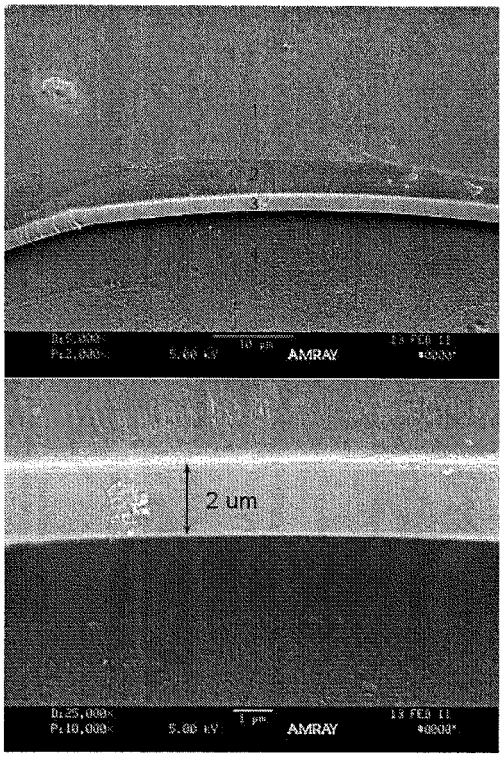
FIG. 3

At. %	N	O	F	Al	Si	Y
1	0.6	57.8	0.4	0.0	0.7	40.5
2	0.5	53.9	2.5	0.0	1.1	41.9
3	0.0	28.0	0.0	46.1	1.0	1.1
4	1.9	55.3	0.0	1.0	41.3	0.6

- Cross-section of coating has been analyzed from a fracture.
- Thickness of barrier layer measured about 2 um.
- Thickness of yttria coating measured about 3 um.
- Both coatings are intact after being used in fluorine environment.

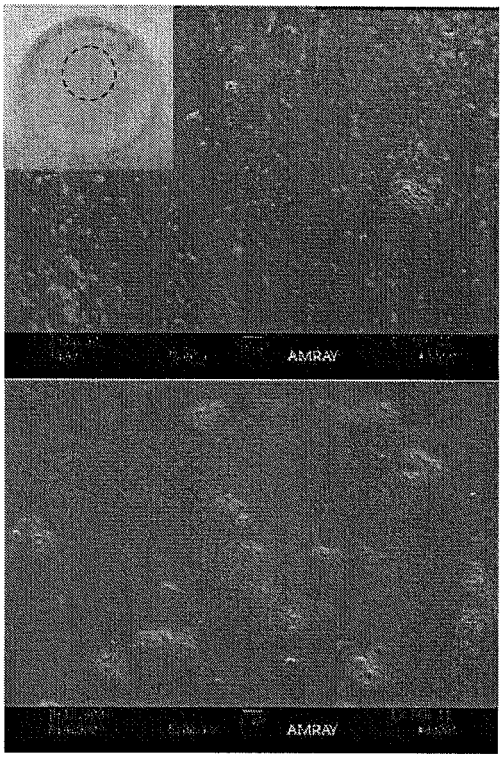
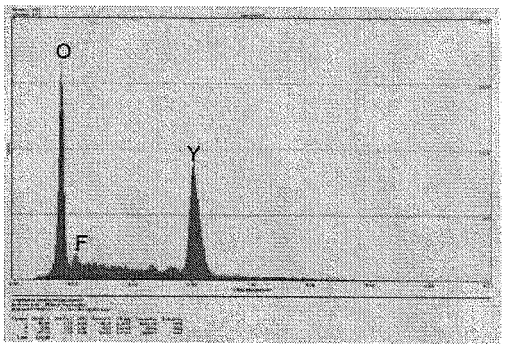
FIG. 4

O	F	Y
At. %	76.3	4.0	19.7

- Yttria coating shows smooth and dense surface that is different from frontside of coating flakes.
- No sign of fluorine corrosion.
- Good adhesion strength: no delamination by Scotch tape test.
