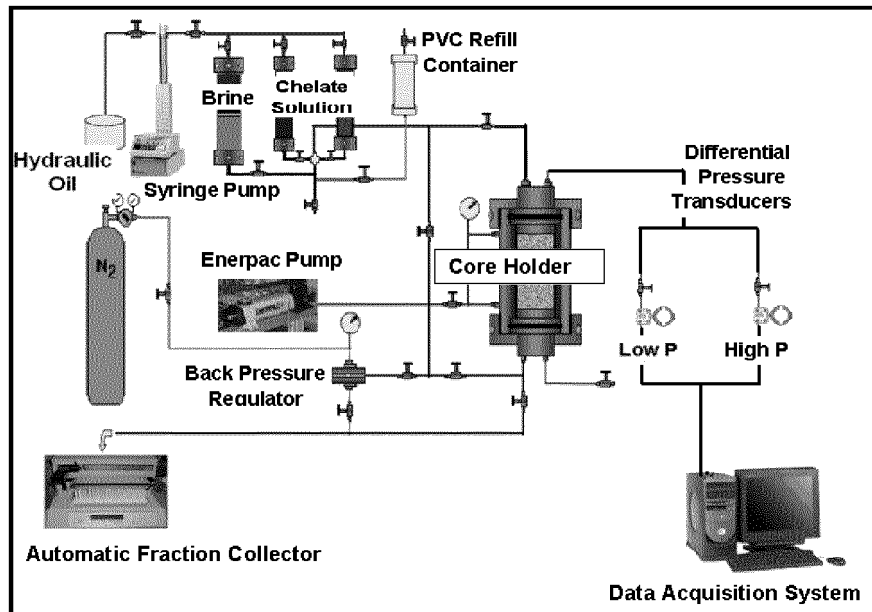
Fig. 1- Core flooding set-up.

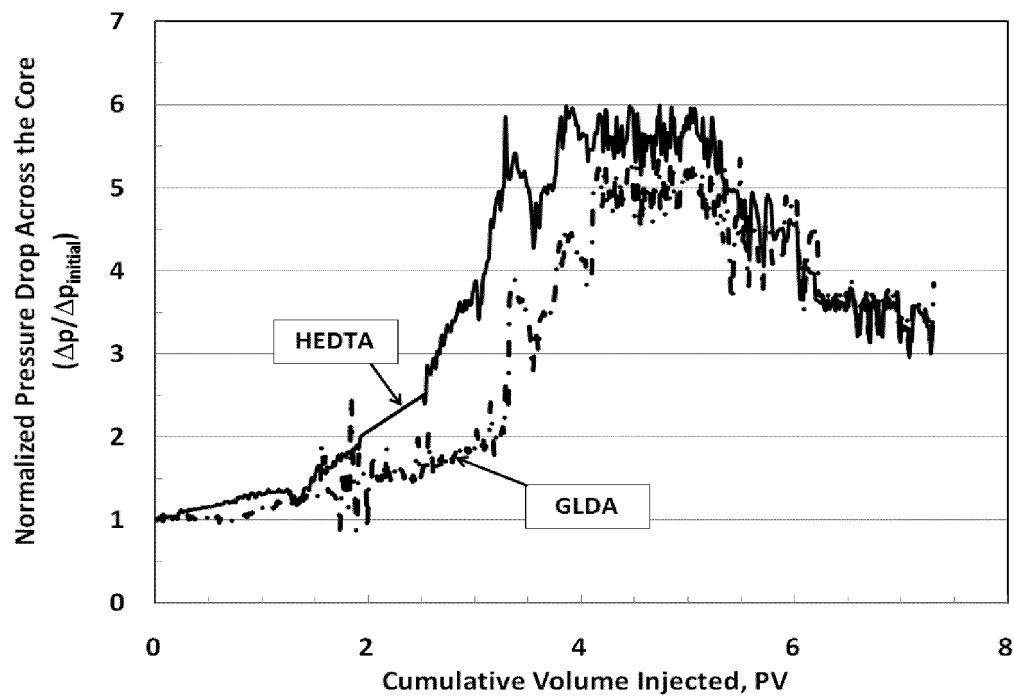
Fig. 2 - Pressure drop across the core during the core flooding experiment for 0.6M GLDA (pH = 4) and 0.6M HEDTA (pH = 4) at 300°F and 5 cm<sup>3</sup>/min using Berea sandstone cores.

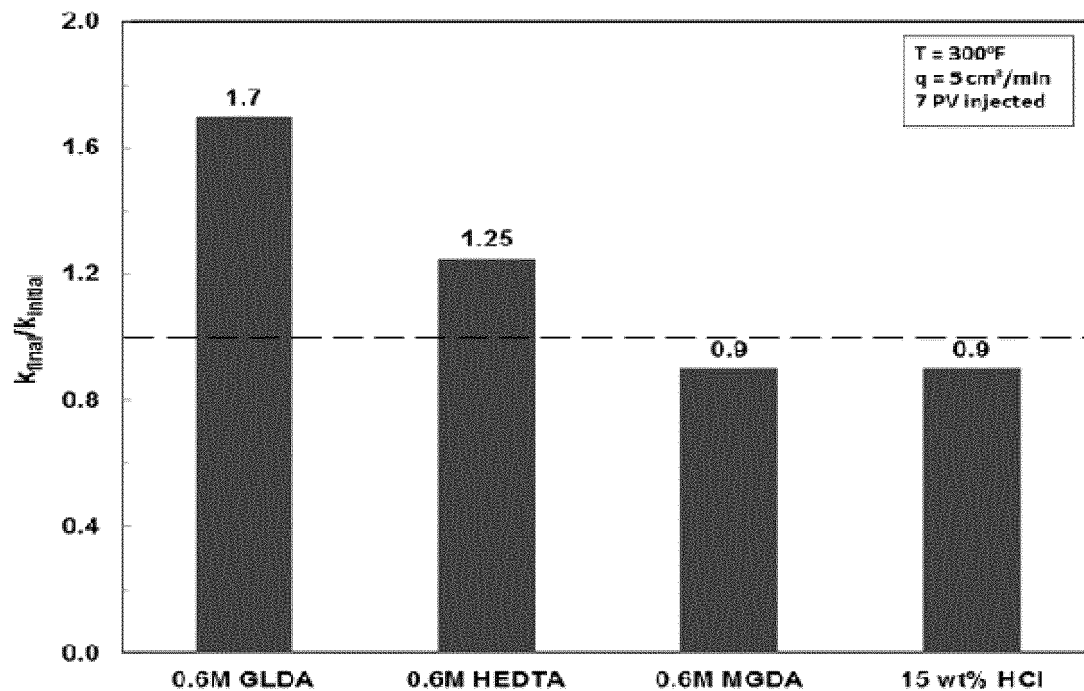
Fig. 3 - Permeability ratio for the Berea sandstone cores treated with 15 wt% HCl and 0.6M chelating agent (pH =4) at 300°F and 5 cm³/min.

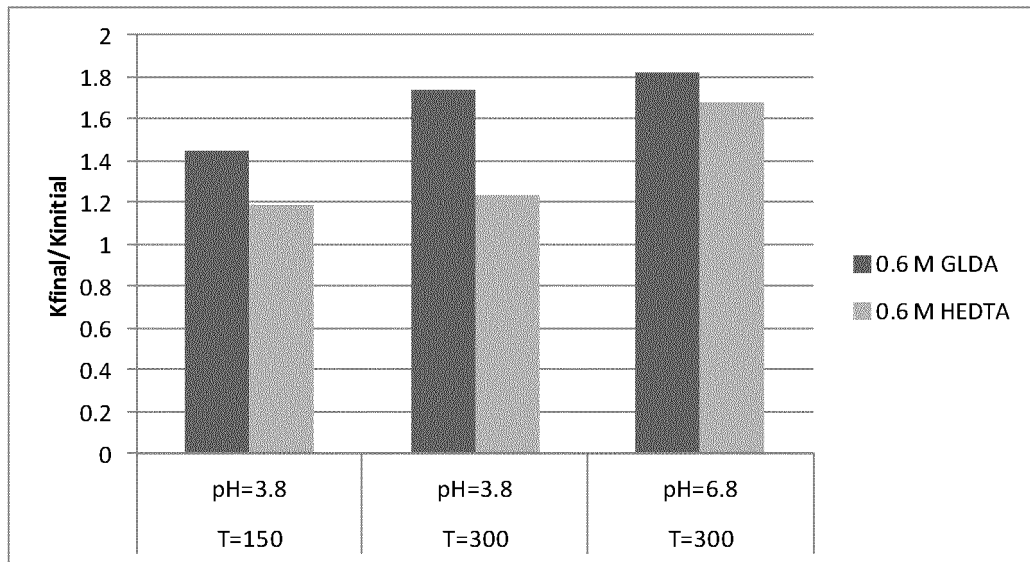
Fig. 4 - Permeability ratio for the Berea sandstone cores treated with 0.6M chelating agent at pH=3.8 or pH=6.8 and at 150 or 300°F and 5 cm<sup>3</sup>/min.

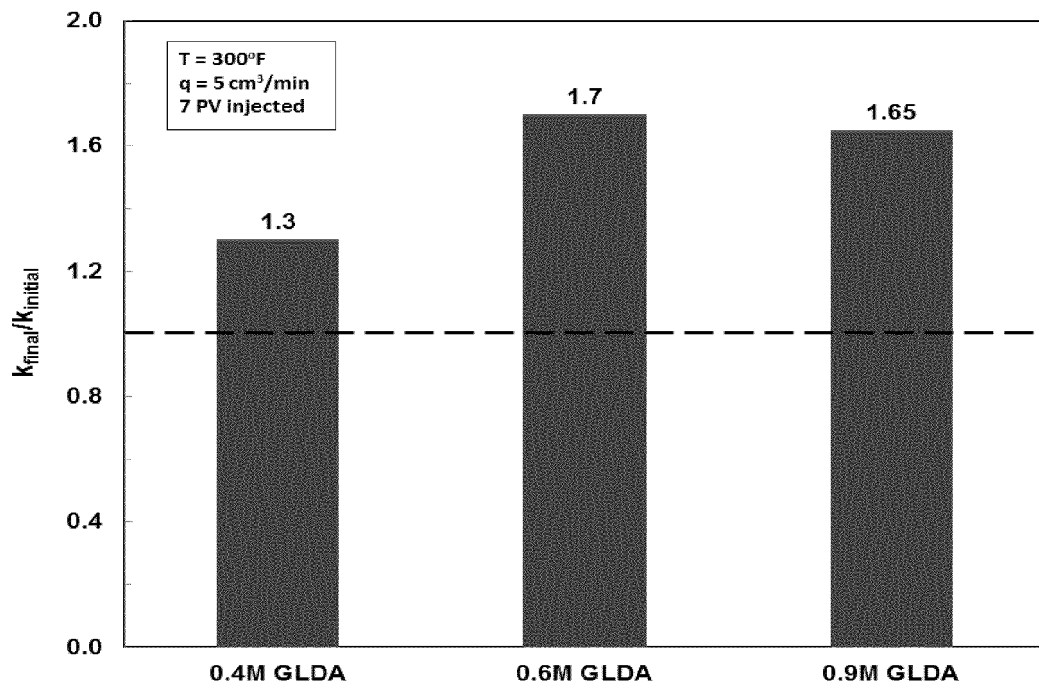
Fig. 5 - Permeability ratio for the Berea sandstone cores after treatment by different GLDA concentration.

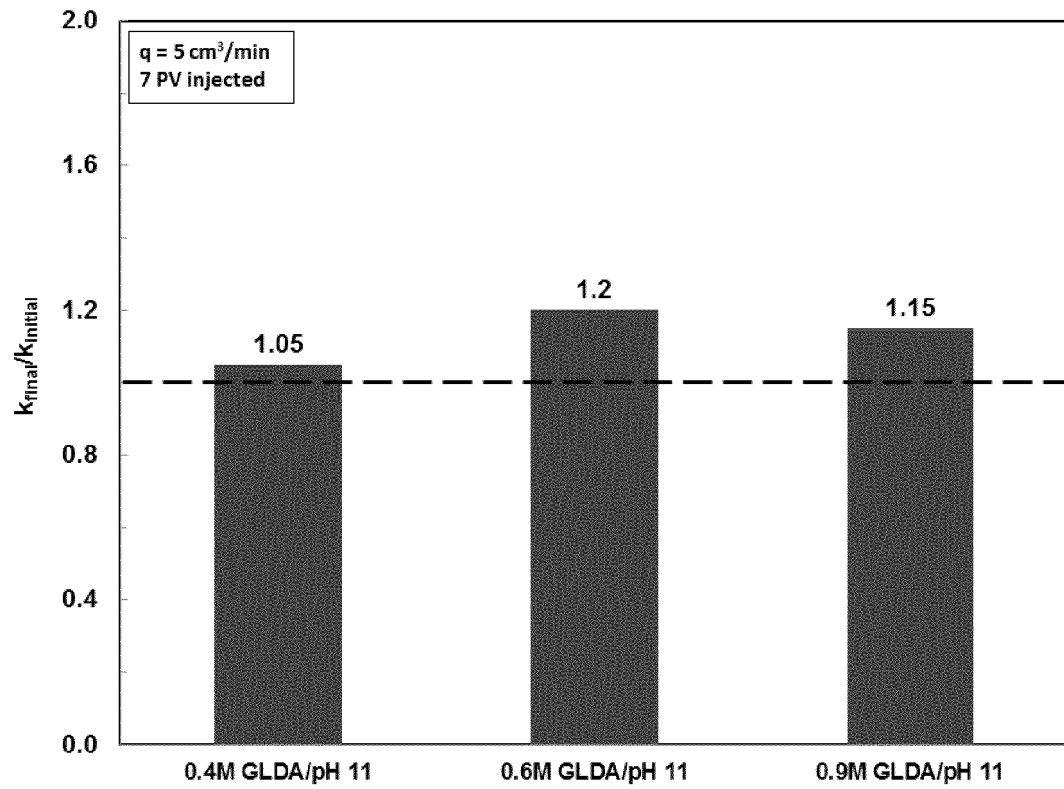
Fig. 6 - Permeability ratio for the Berea sandstone cores after treatment by different GLDA concentration.

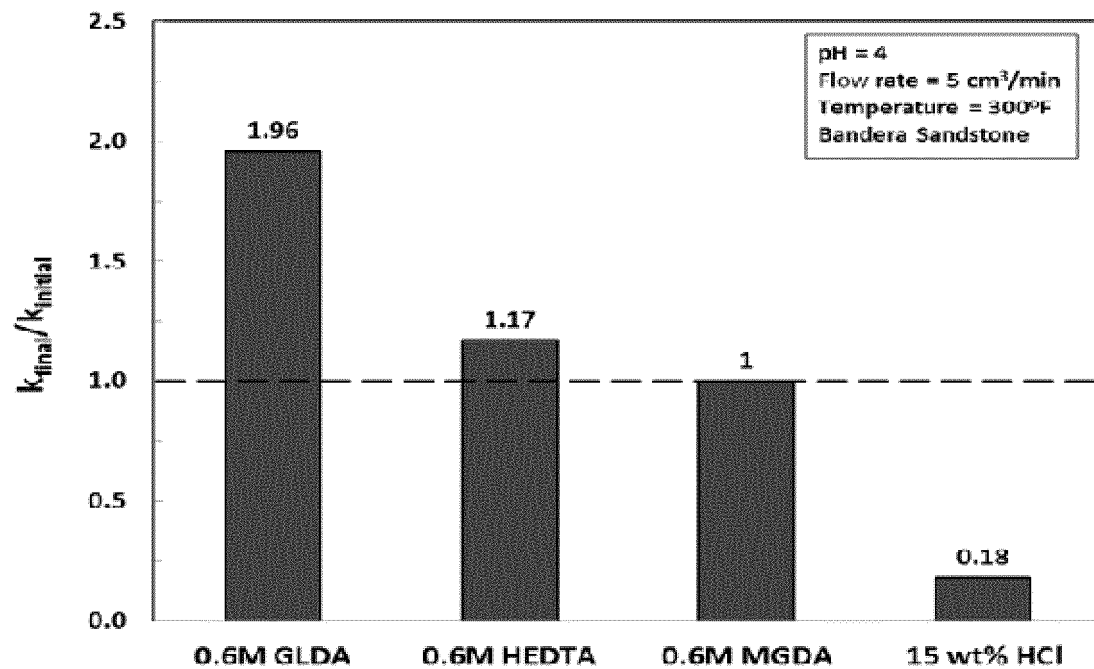
Fig. 7 - Permeability ratio for the Bandera sandstone cores treated with 15 wt% HCl and 0.6M chelate (pH =4) at 300°F and 5 cm<sup>3</sup>/min.

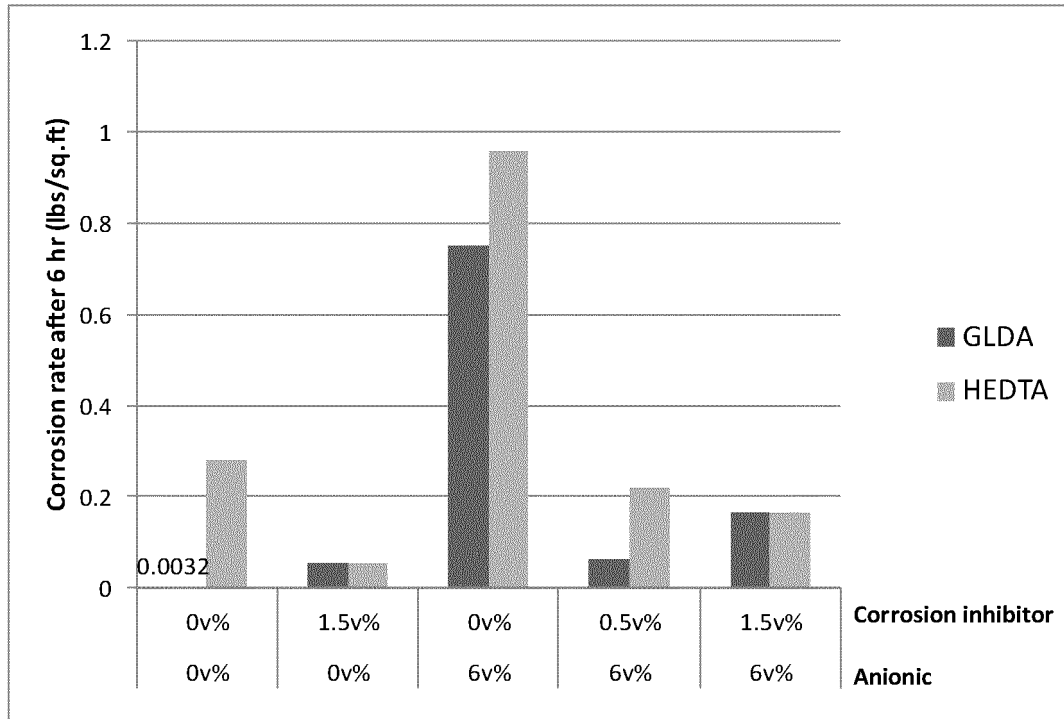
Fig. 8 - The corrosion rate after a 6-hour corrosion test at 325°F (=163°C) of 0.6 M GLDA and HEDTA at pH=3.8 and 1,000psi nitrogen (N<sub>2</sub>) pressure, with 0-1.5 vol% corrosion inhibitor (Armohib 31; 100wt% active ingredient) and 0 or 6 vol% anionic surfactant (Witconate NAS-8; 36wt% active ingredient)

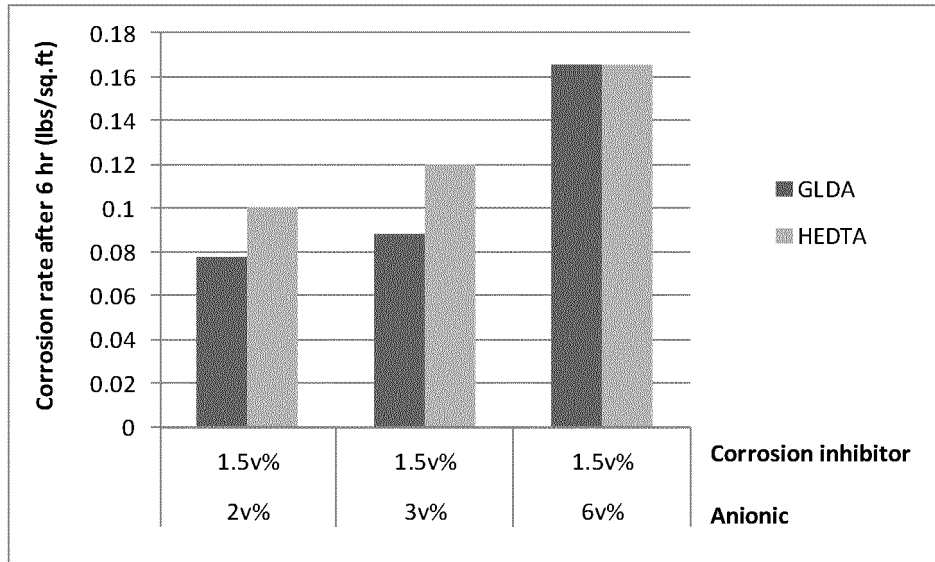
Fig. 9 - The corrosion rate after a 6-hour corrosion test at 325°F (=163°C) of 0.6 M GLDA and HEDTA at pH=3.8 and 1,000psi nitrogen (N<sub>2</sub>) pressure, with 1.5 vol% corrosion inhibitor (Armohib 31; 100wt% active ingredient) and 2-6 vol% anionic surfactant (Witconate NAS-8; 36wt% active ingredient)
