## METHOD OF REPAIRING A STATIONARY SHROUD OF A GAS TURBINE ENGINE USING PLASMA TRANSFERRED ARC WELDING

(54) **REPAIR OF HIGH PRESSURE TURBINE SHROUDS**

## REPAIR OF HIGH PRESSURE TURBINE SHROUDS

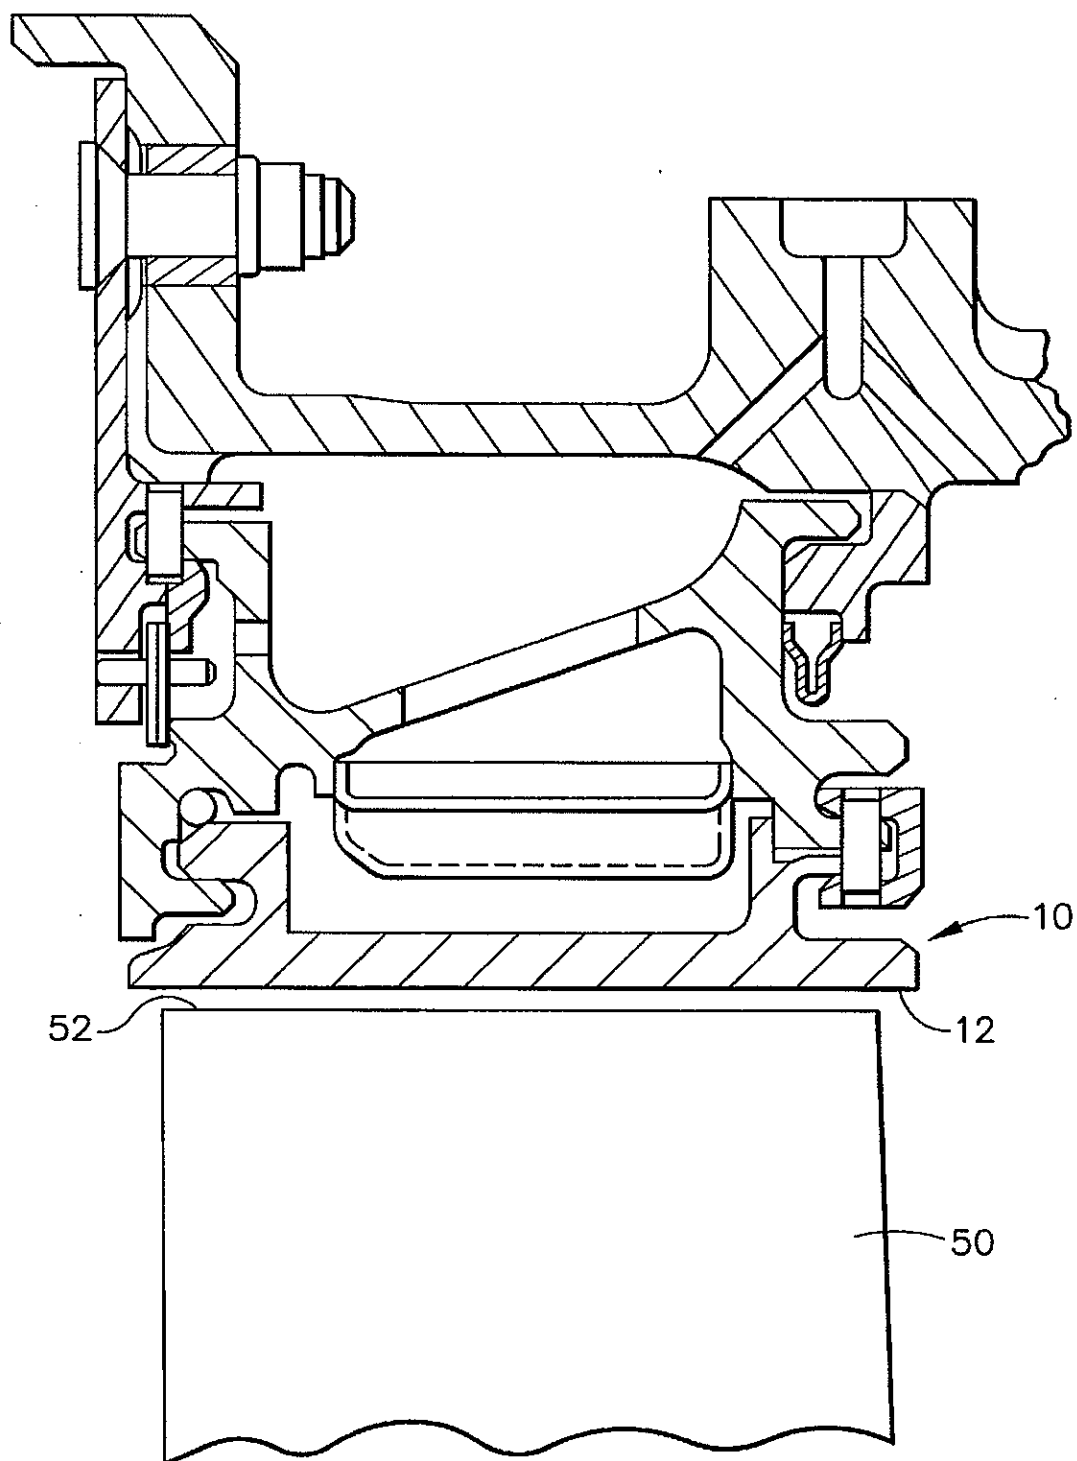
FIG. 1 is a cross-sectional view of a shroud assembly, showing a shroud segment showing the shroud flow path surface adjacent to the tip of a turbine blade, the shroud support, the shroud hanger support and the support case;

FIG. 1 is a cross-sectional of a turbine engine shroud assembly, showing shroud segment 10. In this view, the shroud segment 10 has a flow path surface 12. Also shown for illustration purposes is a turbine blade 50 having a tip 52 immediately adjacent to the flow path surface 12 of the shroud segment. FIG. 2 is a perspective view of shroud segment 10 of FIG. 1. The shroud segment has a fore end 14 and an aft end 16. As shown in FIG. 3, a number of shroud segments having sides 18 are assembled together to form a shroud assembly that has the shape of a cylinder surrounding the turbine blades. As the hot gases of combustion move rapidly from the combustors along the interior of the engine and across the shroud flow path surfaces 12 from the fore end 14 of the shroud segments to the aft end 16 of the shroud segments, the turbine blades are rotated. As can be seen, the tighter the tolerance between the shroud segments and the blades, the more efficient the engine will operate, since smaller volumes of gases will escape across the shroud flow path.

With reference to FIG. 1, turbine blades 50 are designed with tips 52 to cut into the flow path surface 12 of the shroud segments, which generally are comprised of a rub-compliant material. Of course, during the course of engine life, the clearance between the blade 52 and flow path surface 12 will gradually increase just from the operation of the rotating blades against the fixed shroud assemblies at various operating temperatures. Furthermore, as the hot gases of combustion pass along the engine interior across the shroud assembly from the fore rails to the aft rails, mechanical erosion of material from the shroud assemblies will also occur, thus increasing the clearance between the blades and the shroud assembly. Also, the hot gases of combustion contain a number of undesirable by-products which will cause not only oxidation, but also corrosion of the shroud assembly materials. Because the shroud assembly is comprised of a number of shroud segments assembled together to form a ring, as the shroud flow path material is removed, by whatever process described above, a gap develops along the shroud sides 18 between the shroud segments. Eventually, as engine efficiency continues to decrease, the engine must be refurbished to restore the engine parts, including the shroud segments to their original conditions, both dimensionally and materially.

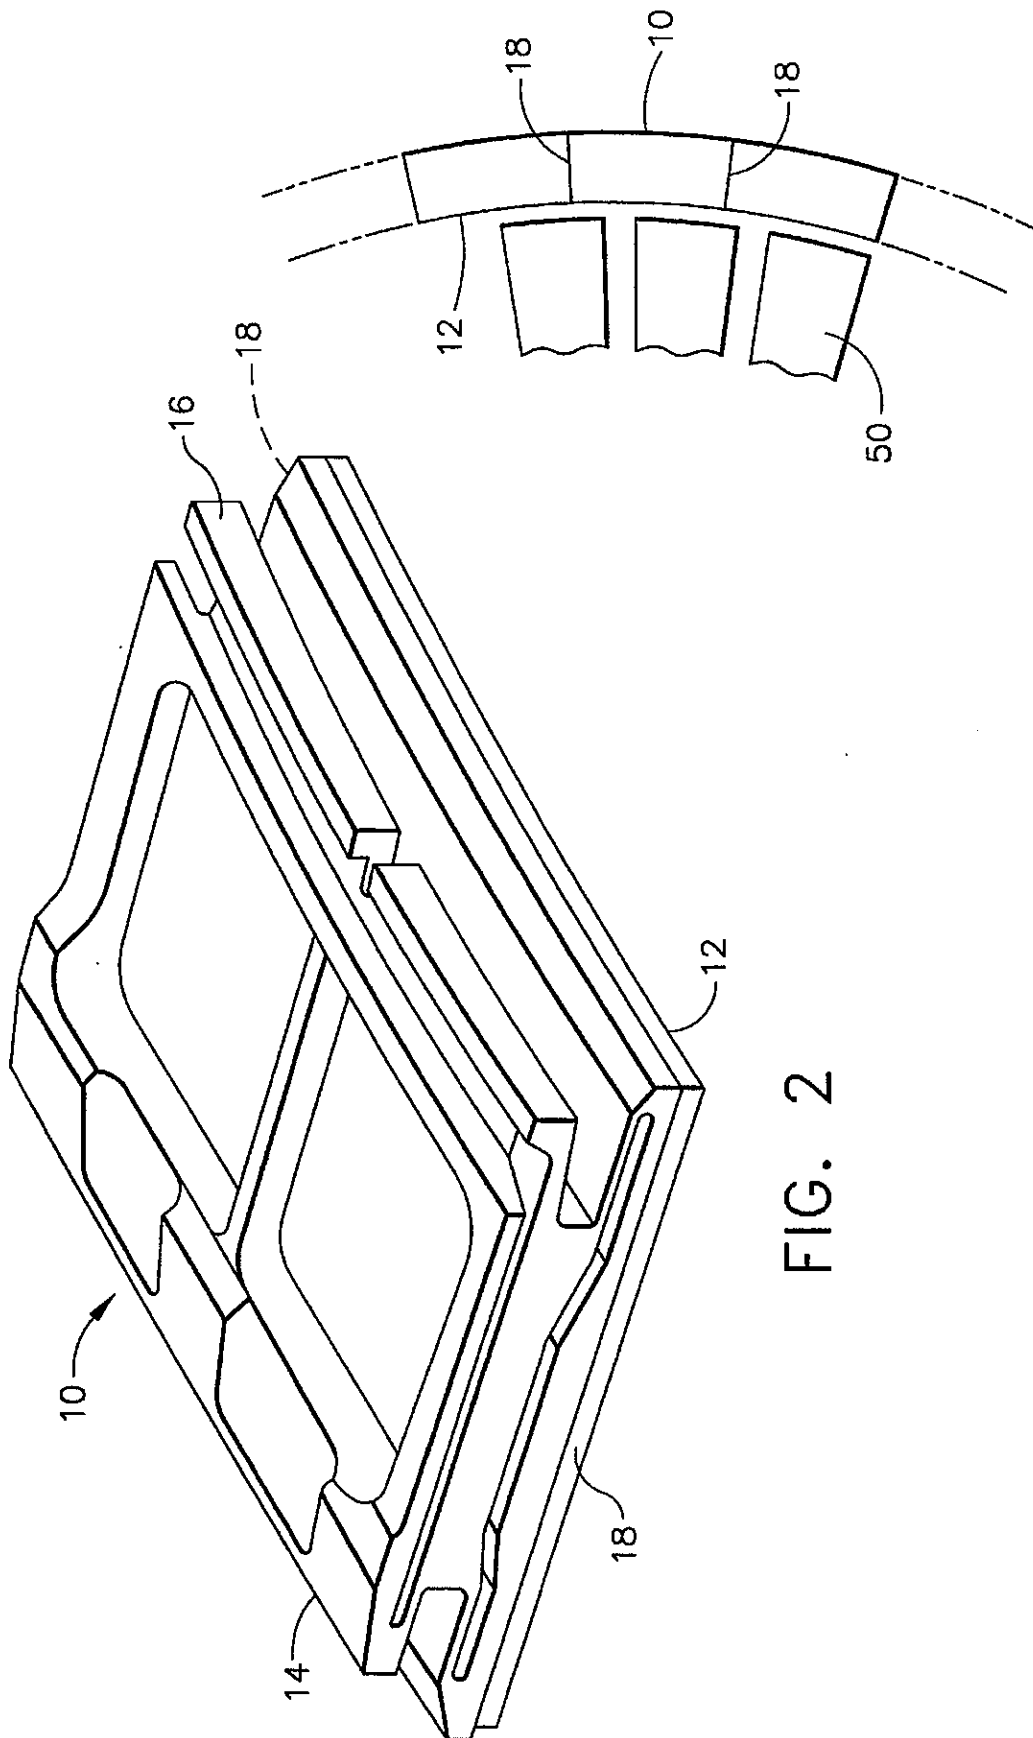
FIG. 2 is a perspective view of a shroud segment; and

FIG. 3 is a partial perspective view of a shroud assembly, comprised of a series of shroud segments assembled to form a portion of a cylinder around turbine blades.
