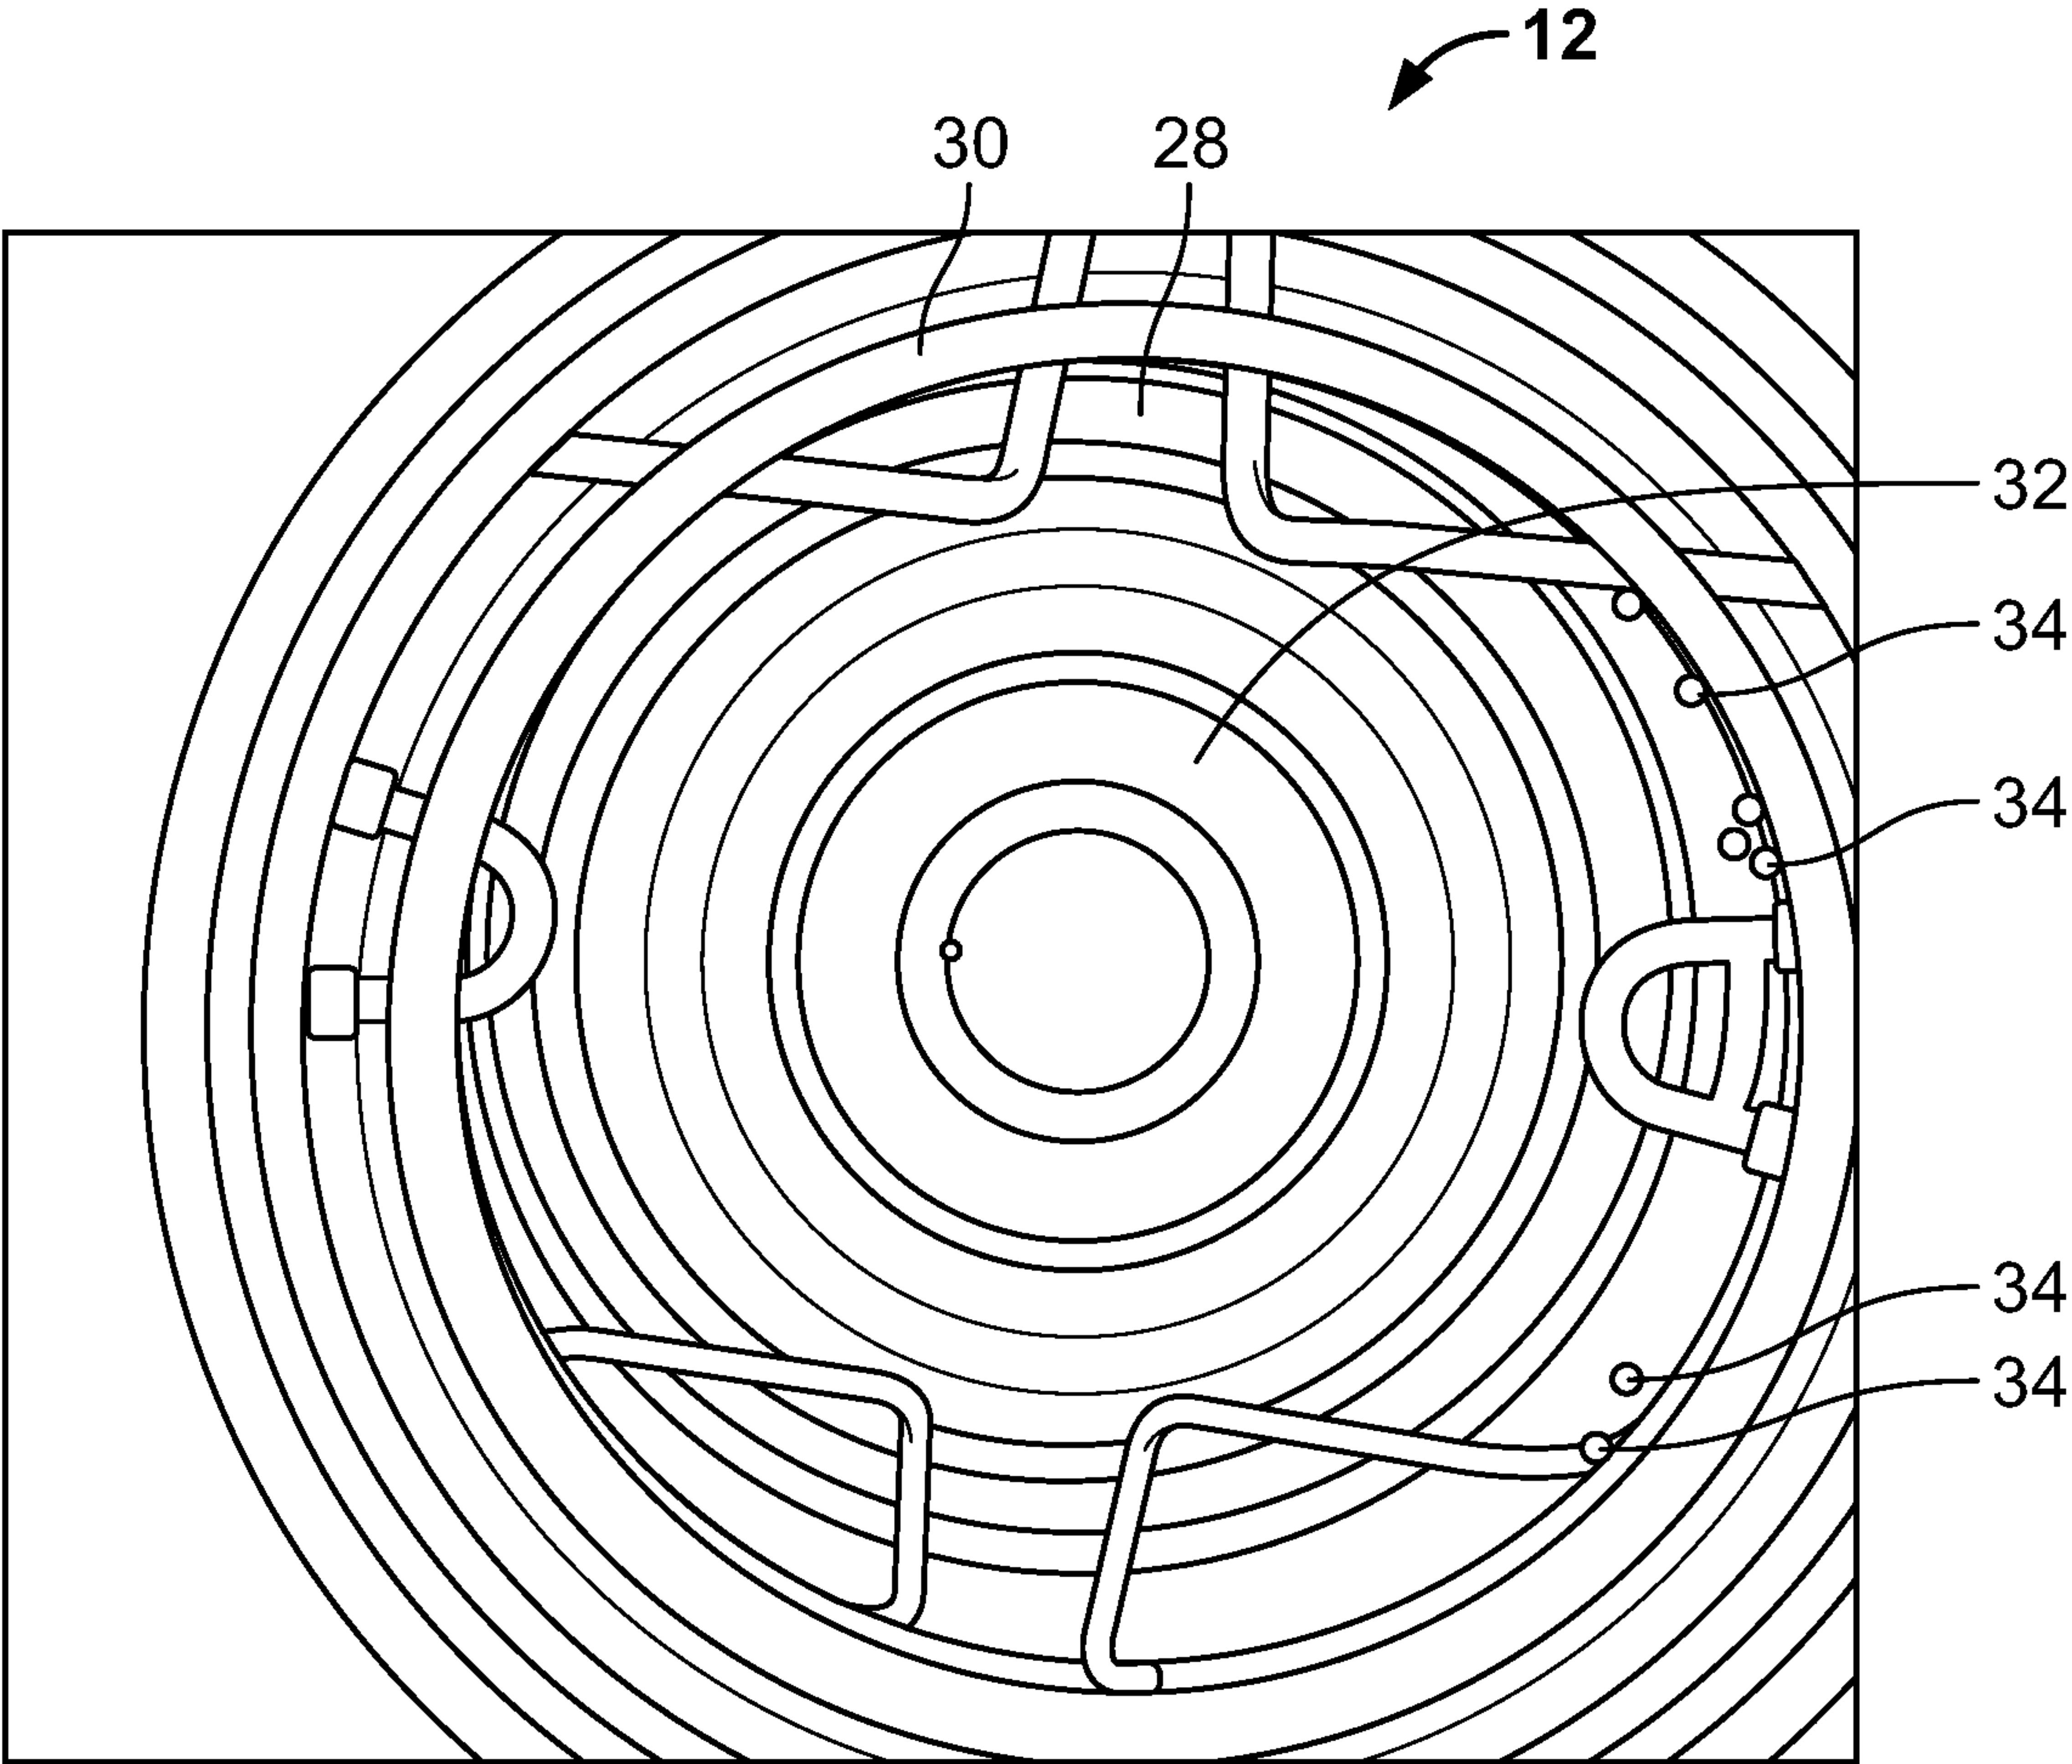
**FIG. 2**

Image of Container with 125 um Particles on Sidewall

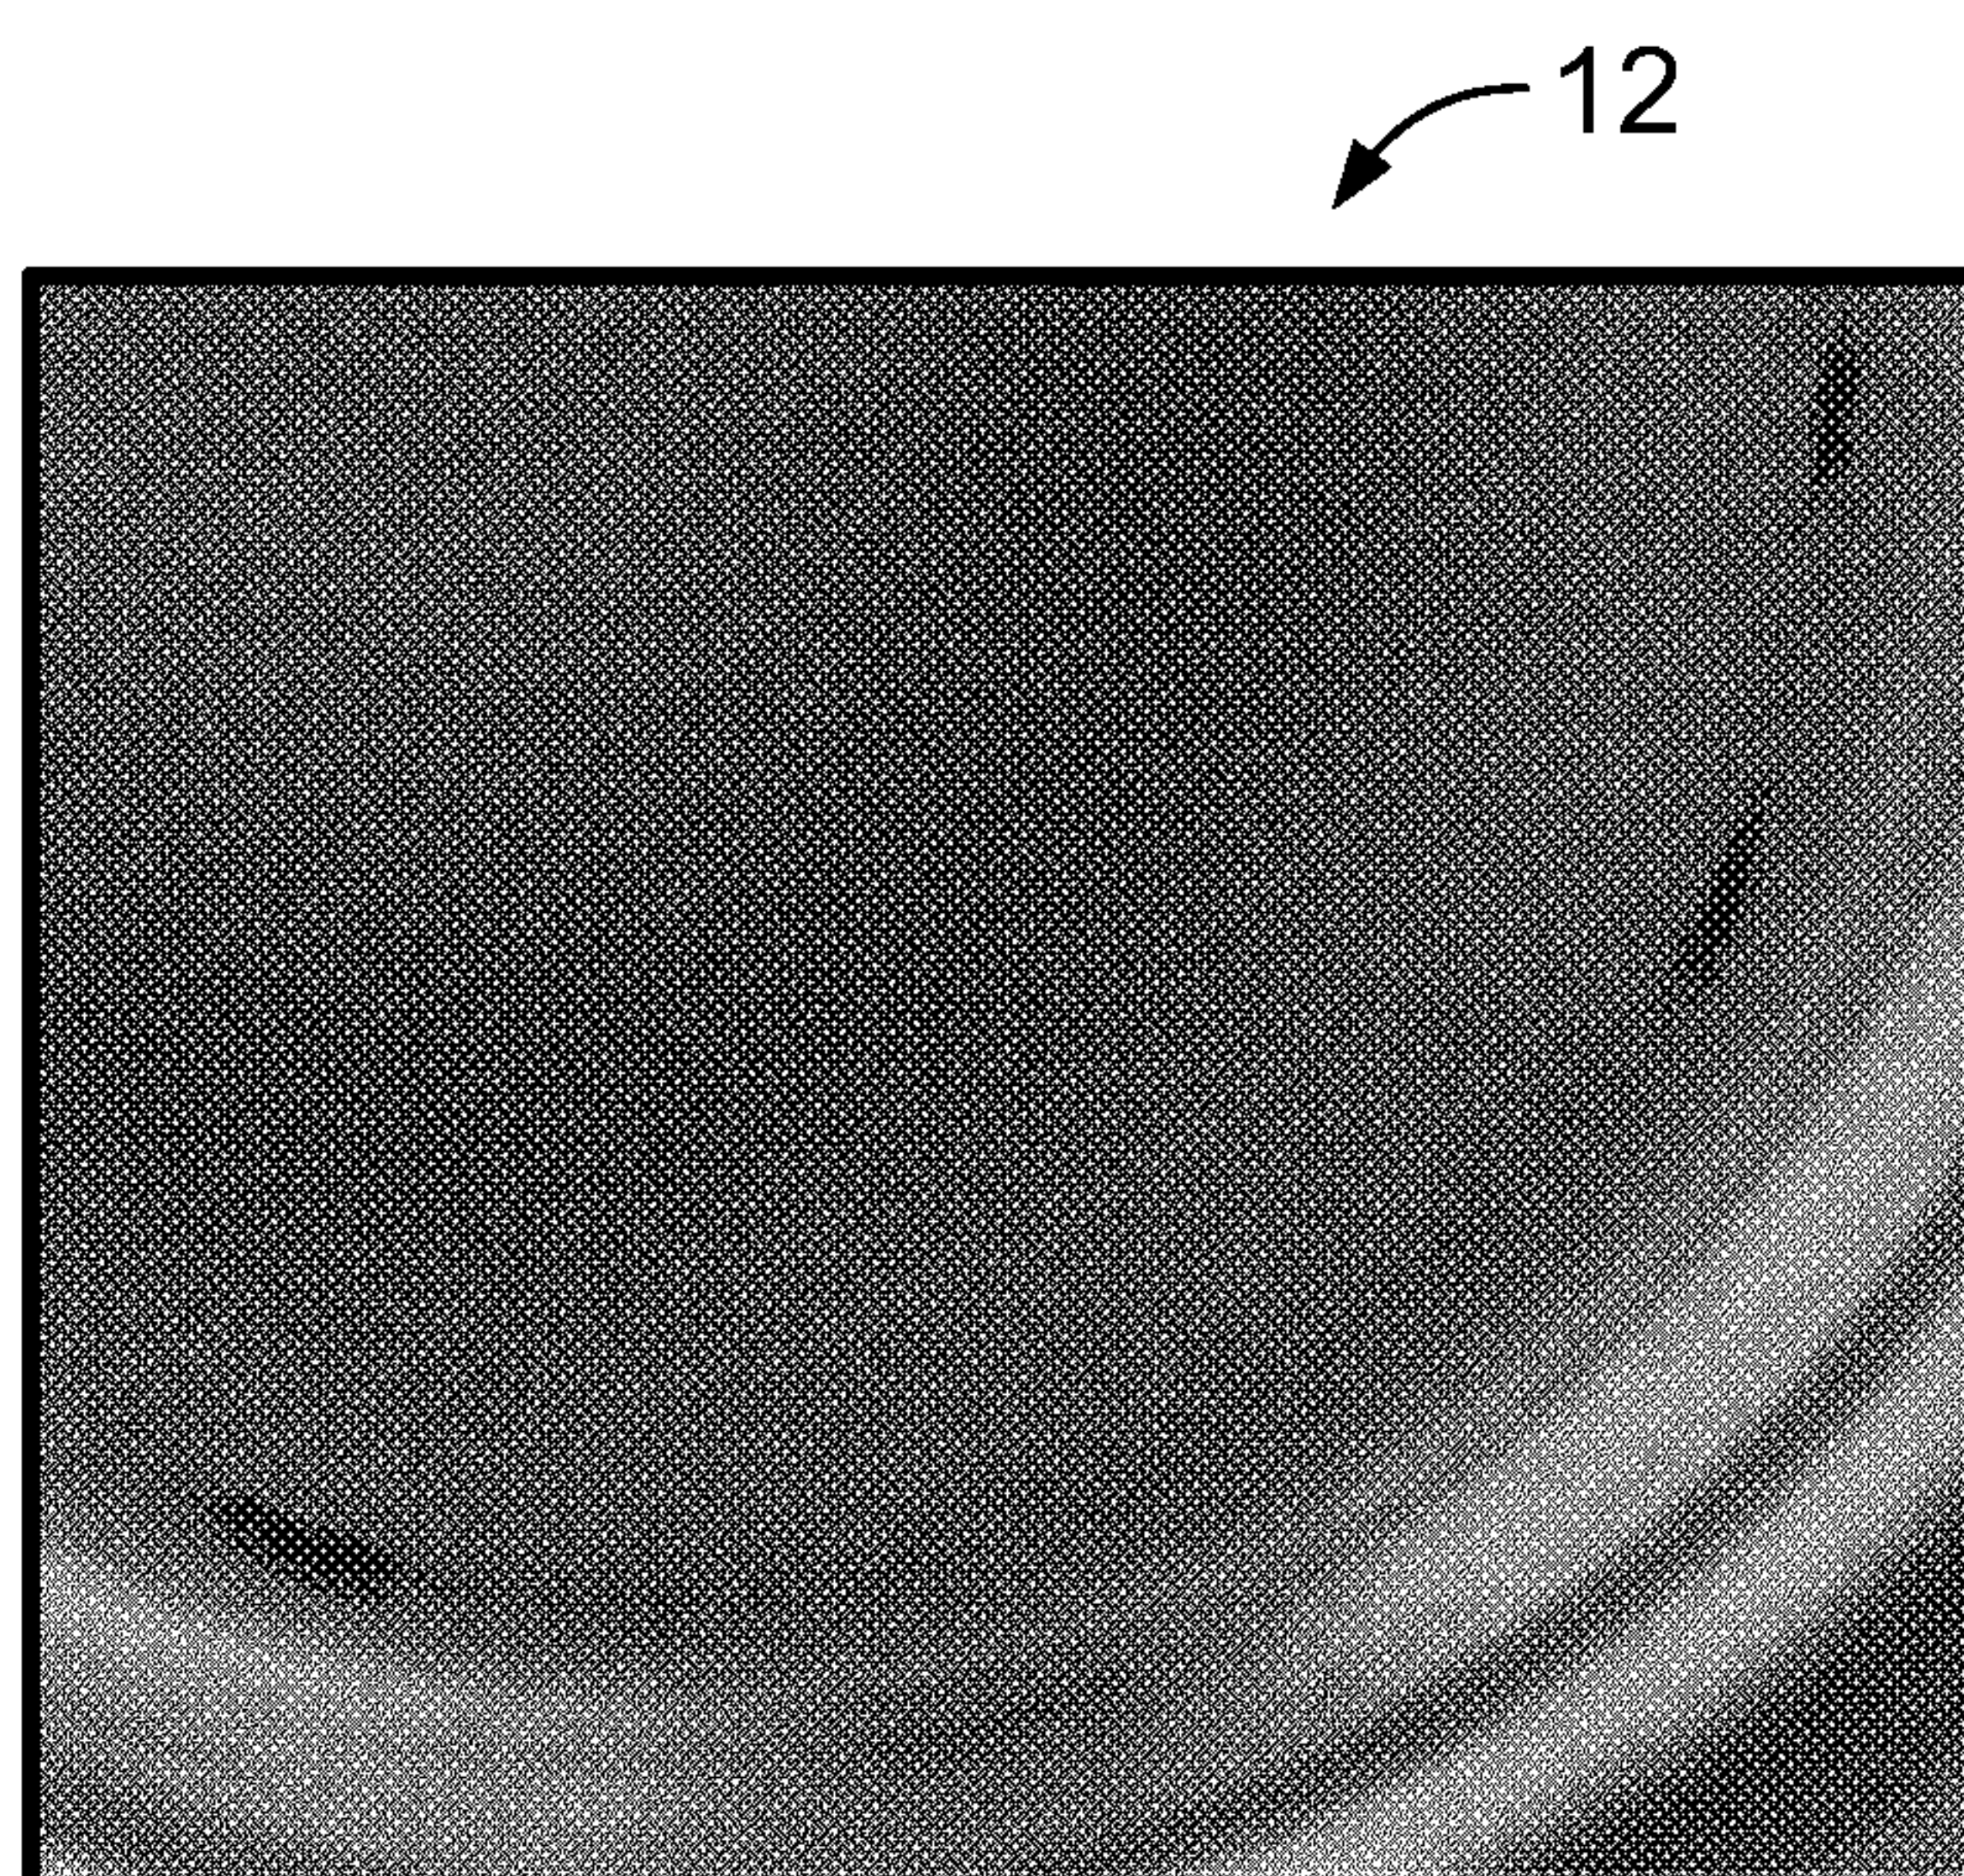
**FIG. 3A**

Image with Particles at 3,4,  
and 7 O'Clock Positions

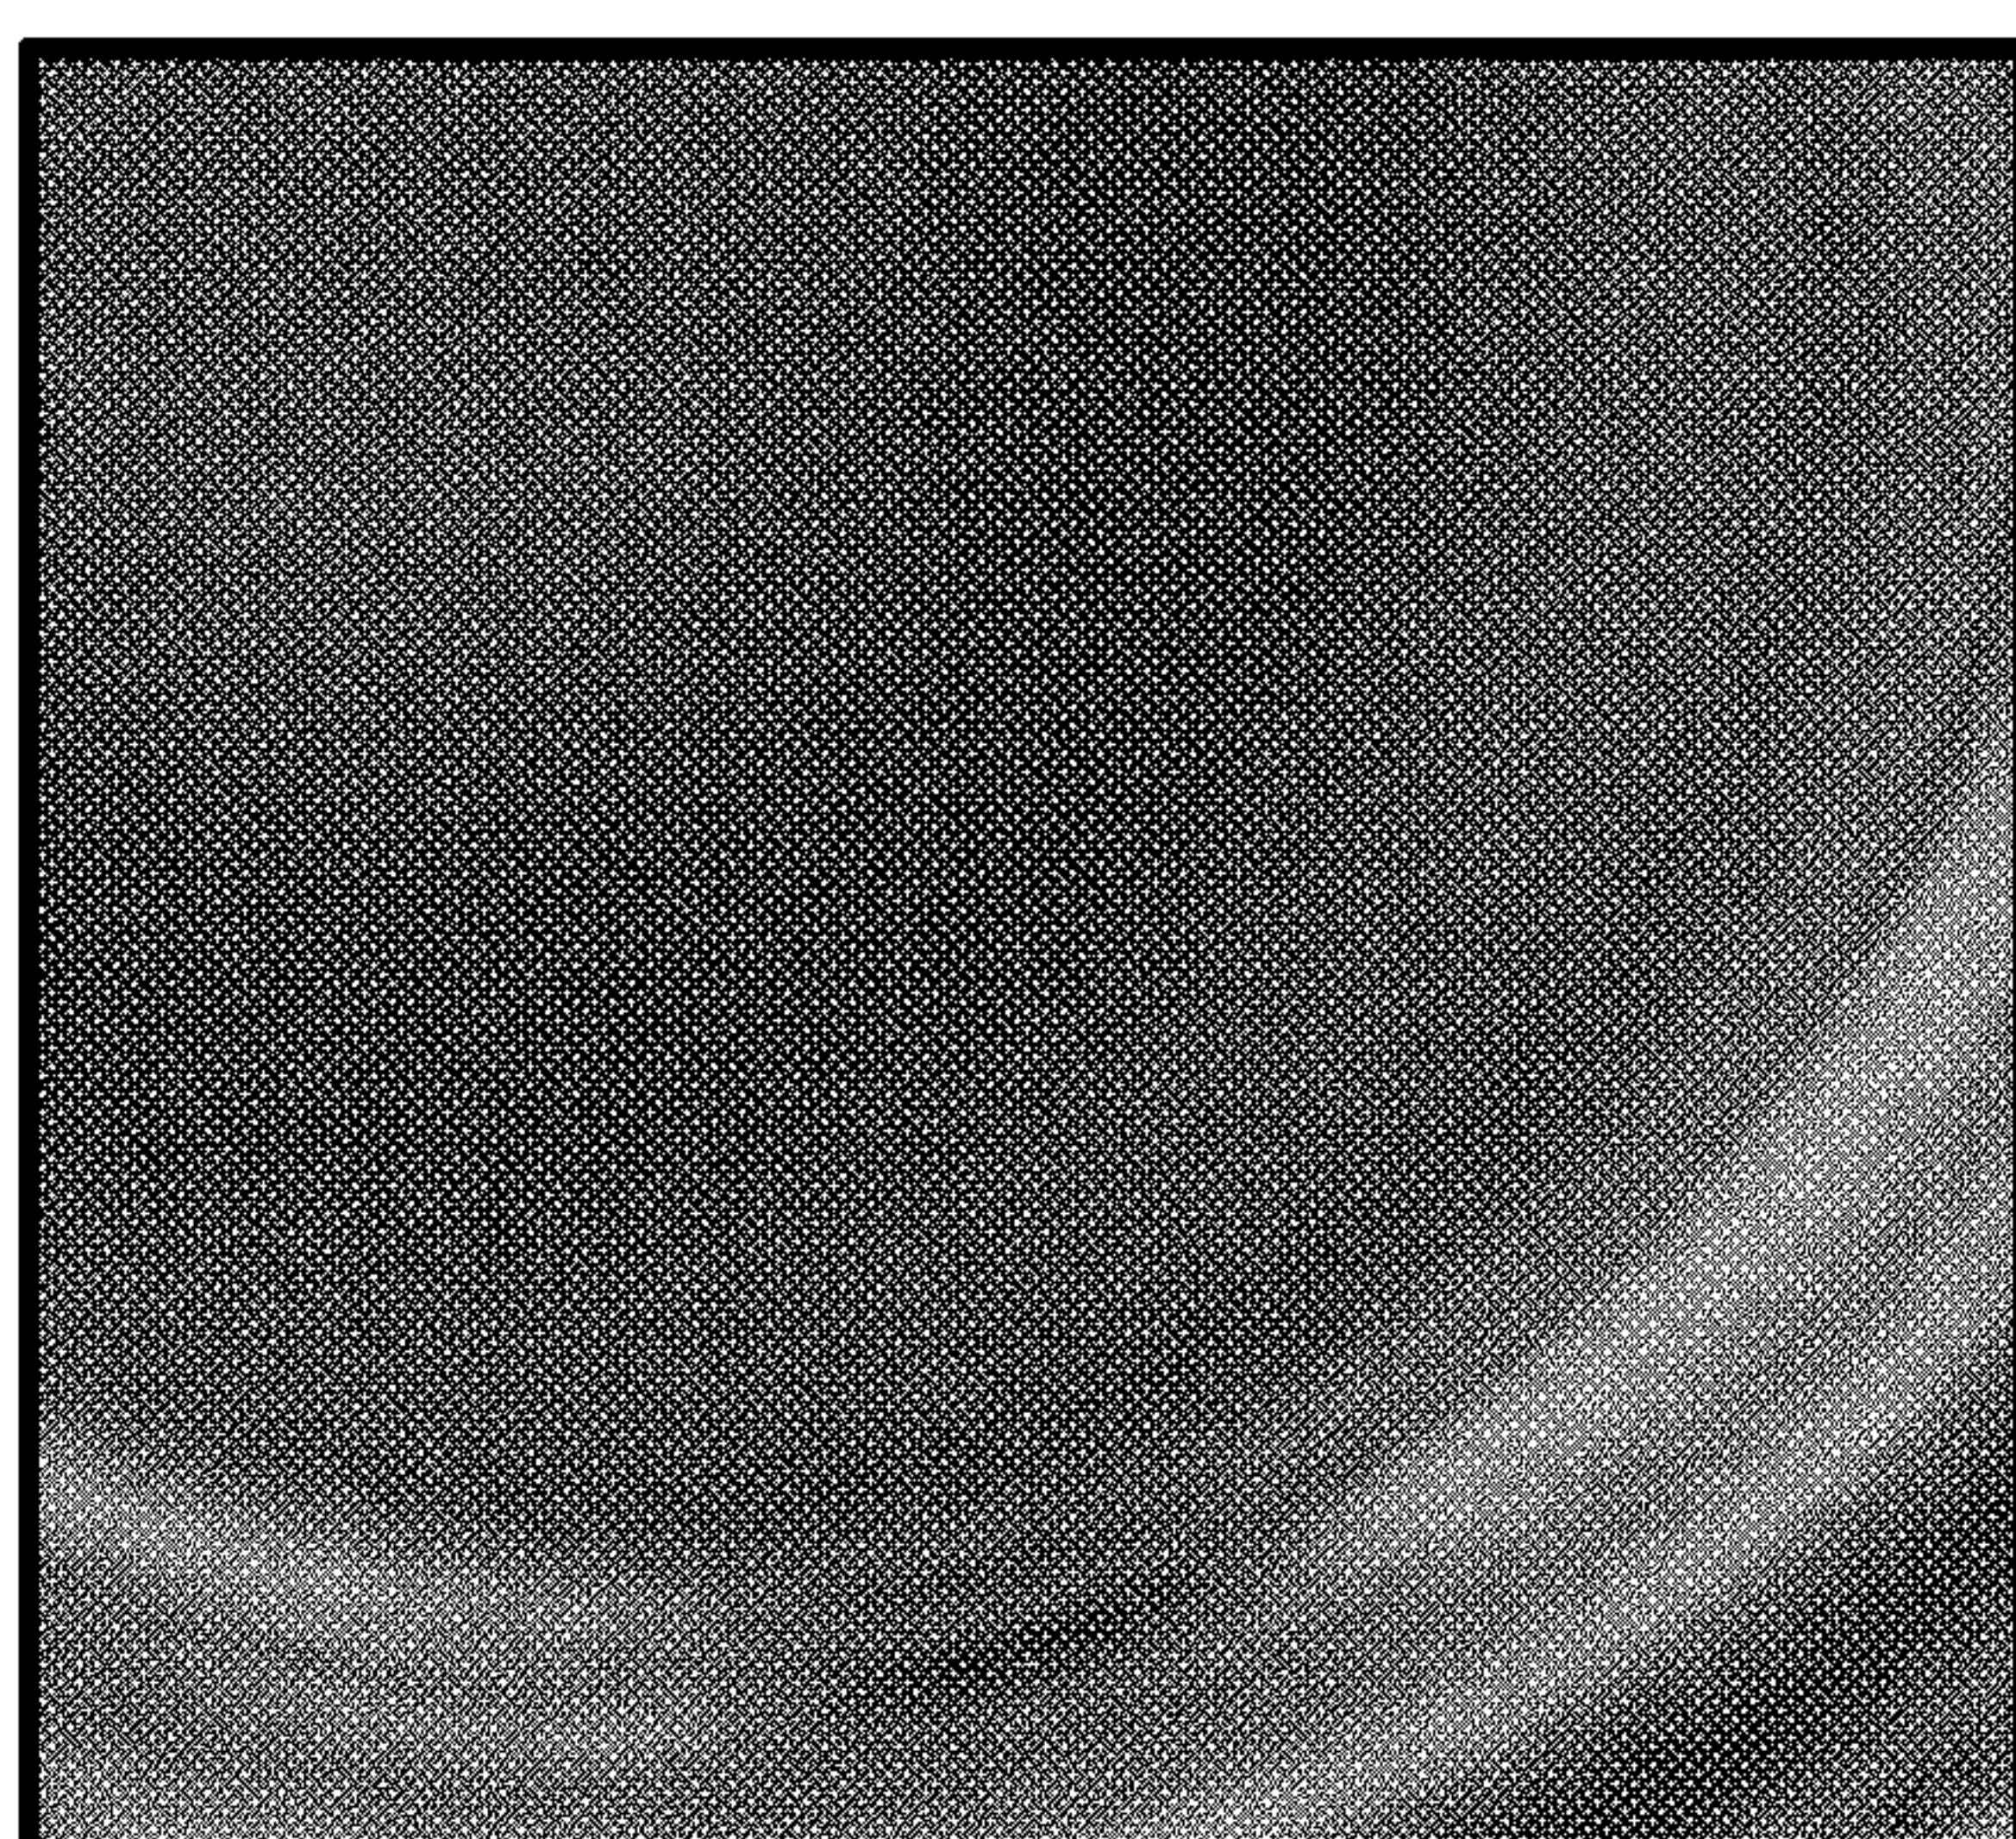
**FIG. 3B**

Image Taken when Camera  
was Slightly Lower, Particles  
are Out of Focus
