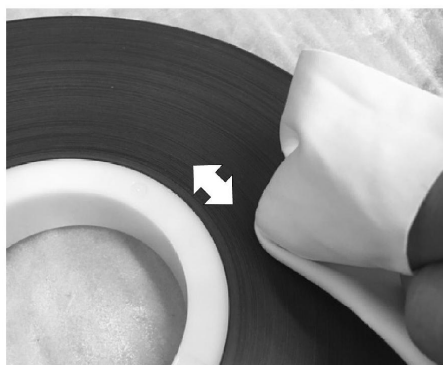
[FIG. 1]

Comparison results of carbon falling-off (transfer)

[Confirmation method]

A waste cloth is rubbed against a slit surface and carbon transfer is confirmed with a microscope

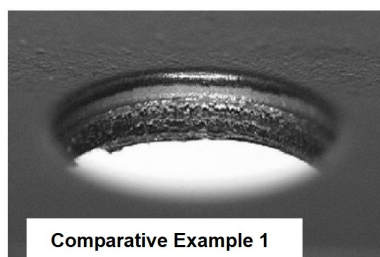
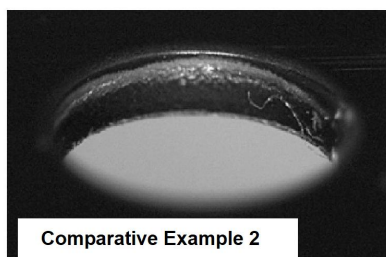
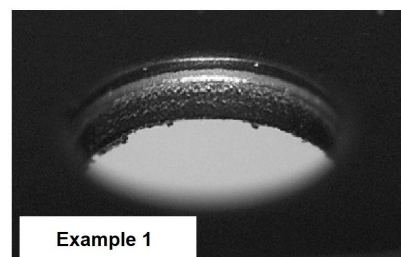
[FIG. 2]

Comparison results of open state of sprocket hole
