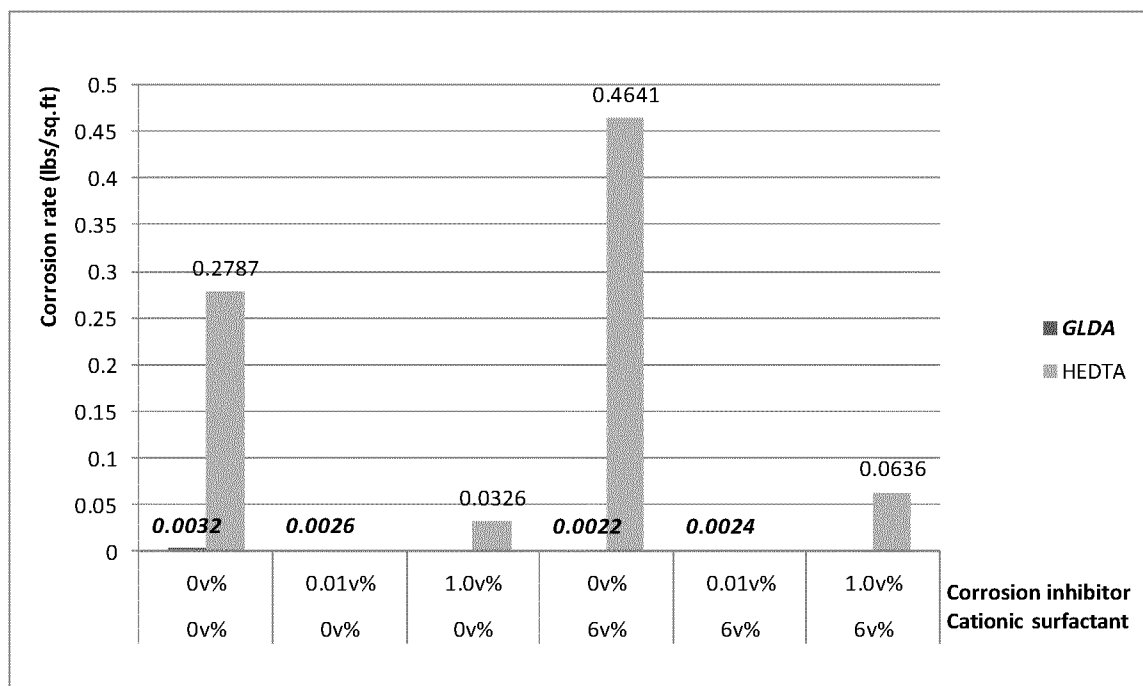
Figure 1 - The corrosion rate after a 6 hour corrosion test at 325°F (=163°C) of 0.6 M GLDA and HEDTA at pH=3.8 and 1000 psi nitrogen (N<sub>2</sub>) pressure, with 0-1.0 vol% corrosion inhibitor (Armohib 31) and 0 or 6 vol% cationic surfactant (Arquad C-35 (35% active ingredient))

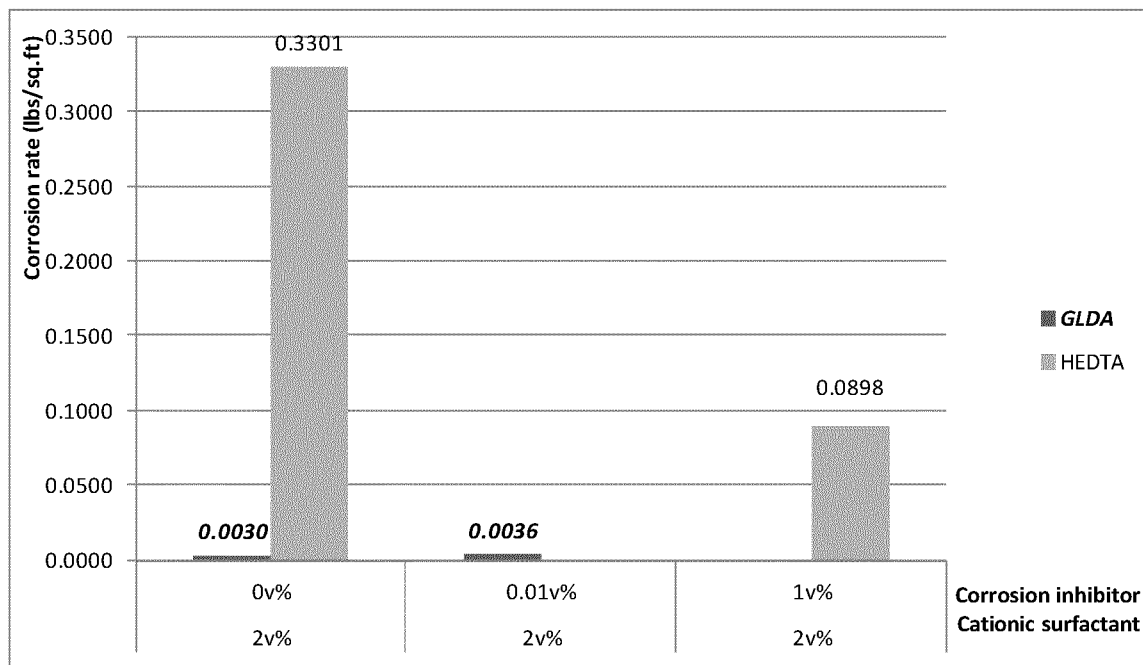
Figure 2 - The corrosion rate after a 6 hour corrosion test at 325°F (=163°C) of 0.6 M GLDA and HEDTA at pH=3.8 and 1000 psi nitrogen (N<sub>2</sub>) pressure, with 0-1.0 vol% corrosion inhibitor (Armohib 31) and 2 vol% cationic surfactant (Ethomeen C/22).

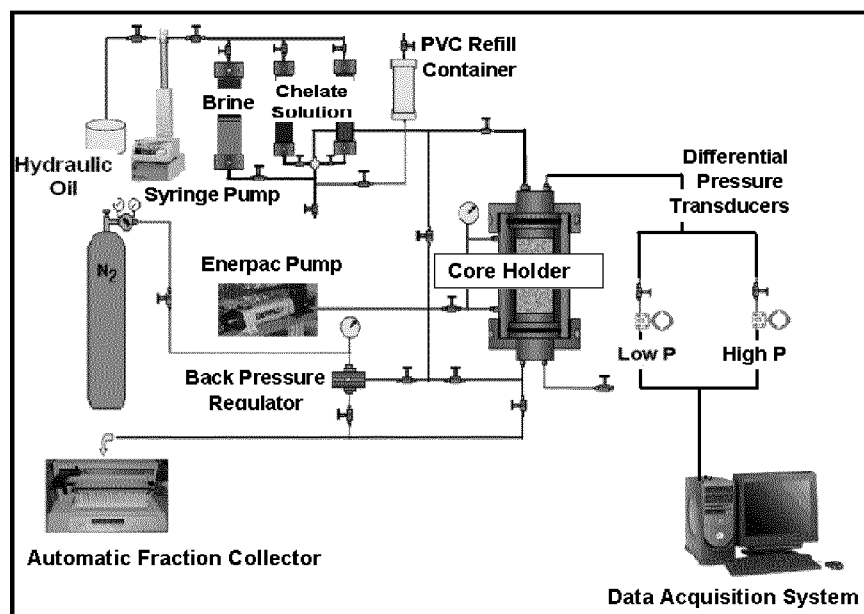
Figure 3 - Core flooding set-up.

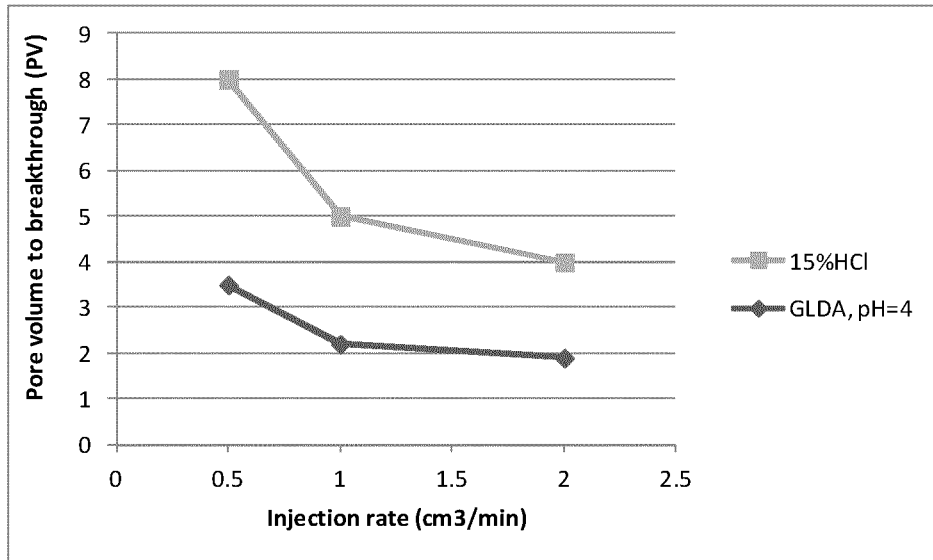
Figure 4 - The pore volume to breakthrough of 20 wt% GLDA at pH=4 compared to 15 wt% HCl in 20-inch Indiana limestone cores as a function of the injection rate.

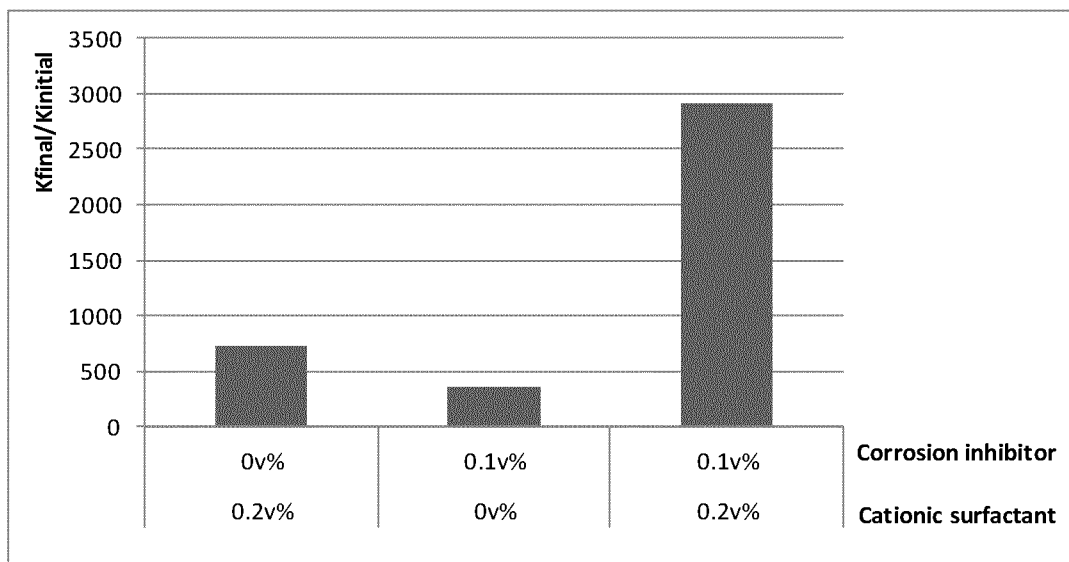
Figure 5 - Permeability ratio for the Indiana limestone cores treated with 0.6M GLDA (pH =4) with corrosion inhibitor (Armohib 31) and/or cationic surfactant (Arquad C-35) at 300°F and 2 cm<sup>3</sup>/min.
