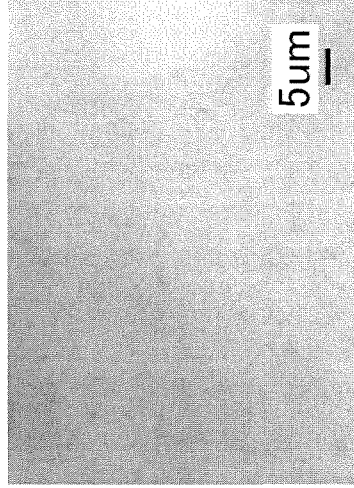
Example 2-1

Few mesh-like defects are seen.

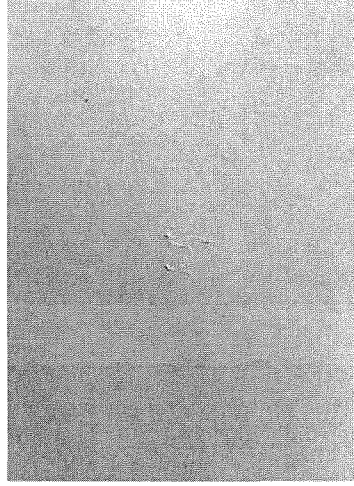
Comparative  
Example 2-1

Mesh-like defects were  
generated in some areas.

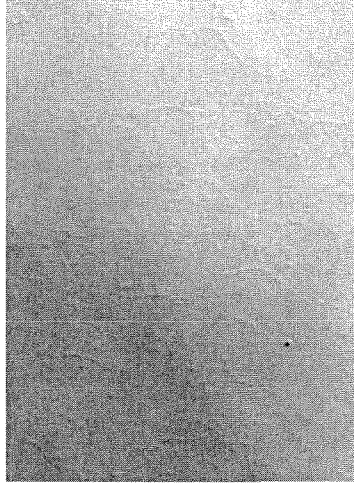
Comparative  
Example 2-2

Mesh-like defects were  
generated in a wide range.
