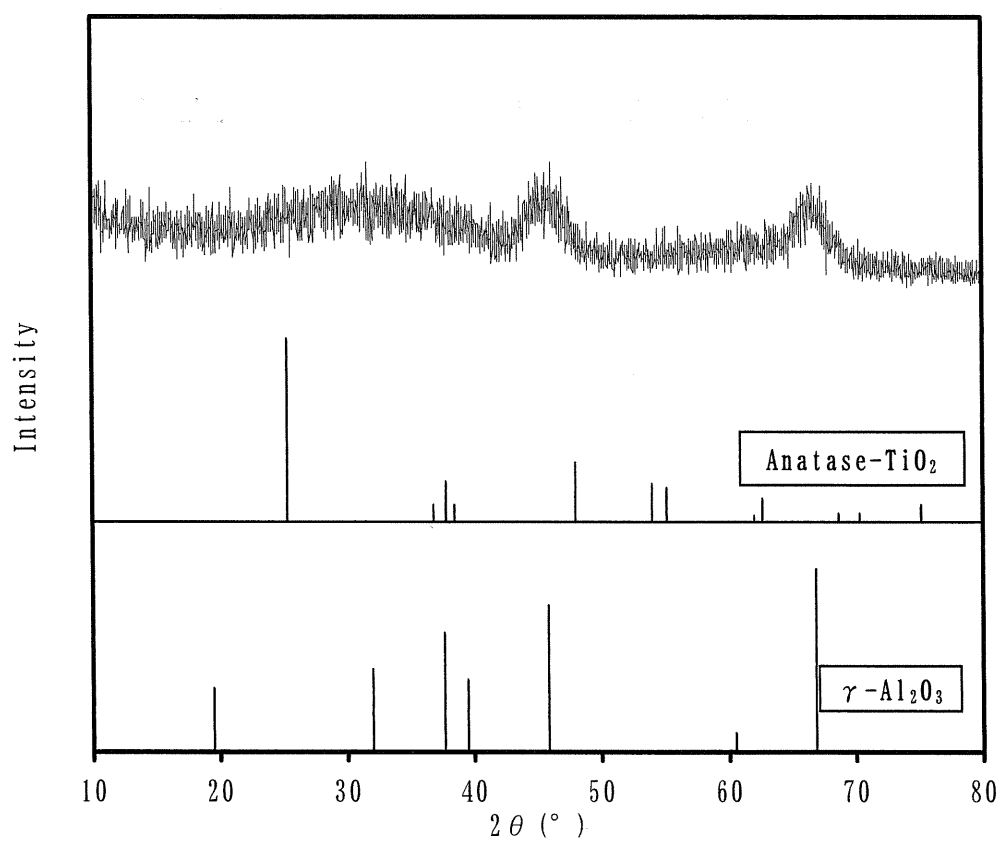
Fig. 1

X-RAY DIFFRACTION PATTERN OF TITANIA-COATED ALUMINA SUPPORT AT-2

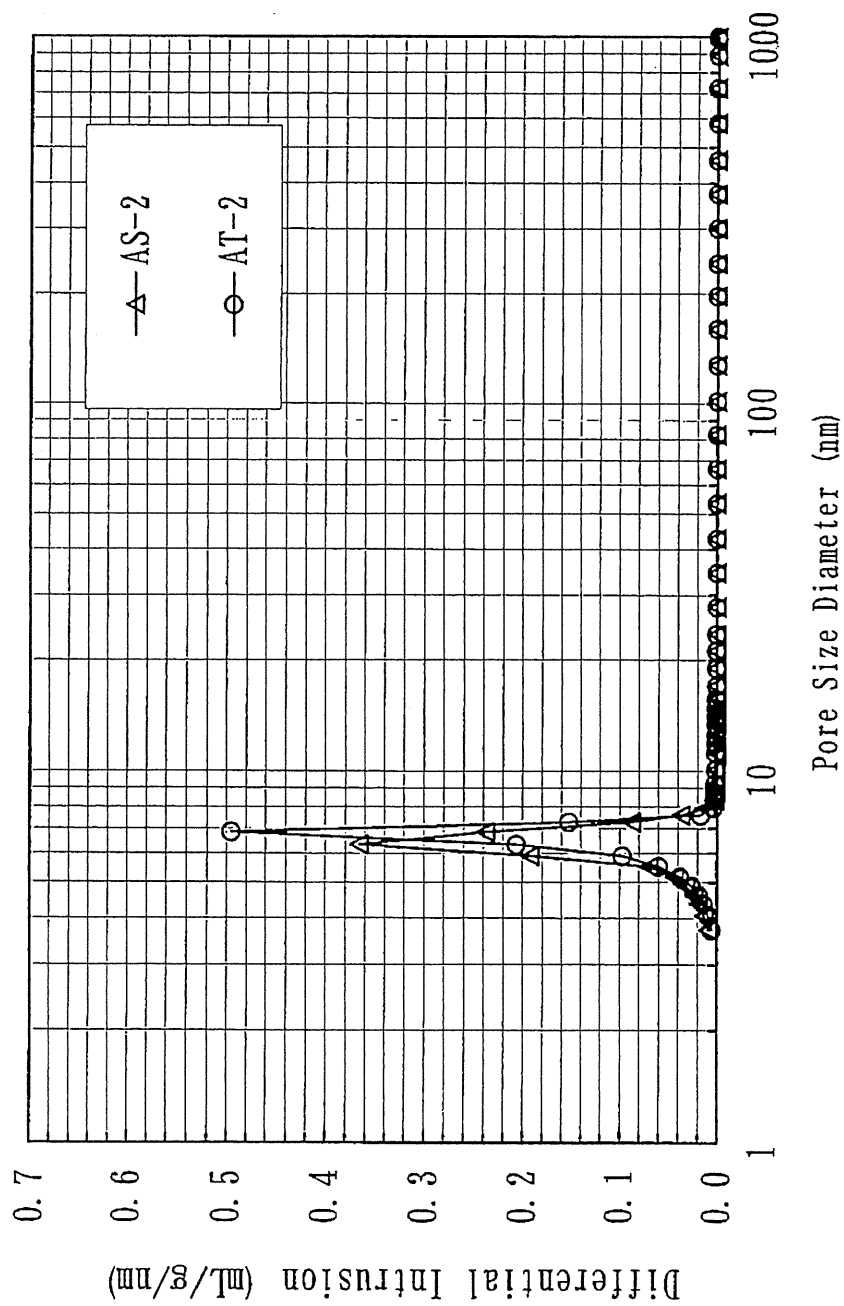
Fig. 2

COMPARISON IN DIFFERENTIAL PORE DISTRIBUTION BETWEEN SUPPORTS AS-2 AND AT-2
